# GLENDAL ELEMNTARY SCHOO DISTRICT SFB PROJECT RECAP

# Glendale Elementary School District SFB Projects: Construction Cost Estimates

**RE: GESD SFB Deficiency Corrections**  
Landmark, Challenger, Mensendick and Smith

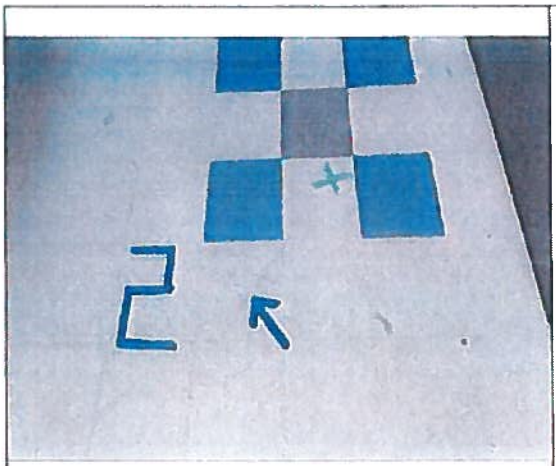
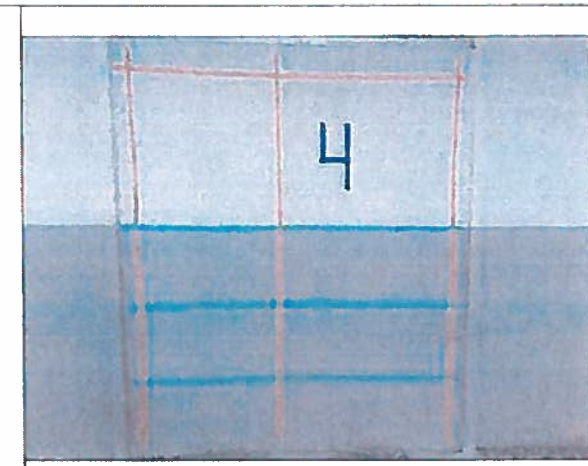
No. 5 Scan 2 SOG: Mensendick, Rm. 624. Approx. 10'x10' area. NWC of Room. No indication of reinf, approx 4" thick. Note crack at blue arrow.	No. 6 Scan 4 Wall: Mensendick, Rm. 537, N wall. Orange-vert & horiz reinf. Green-joint reinf at bottom of wall

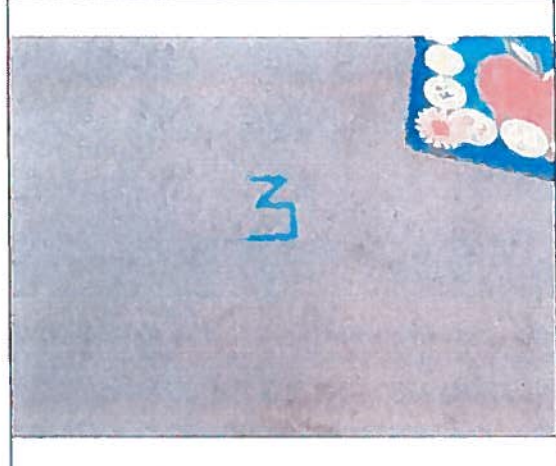
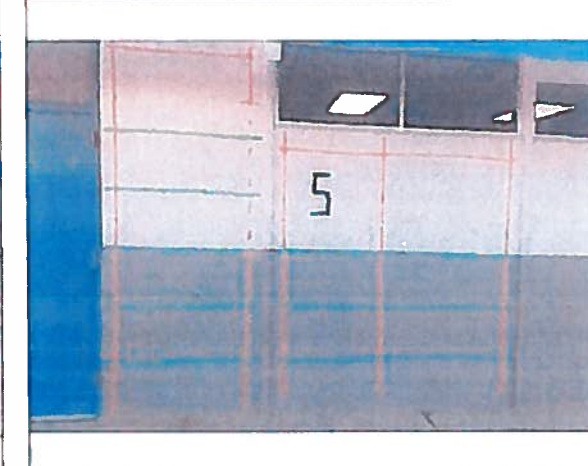
No. 7 Scan 3 SOG: Jack, Rm 528, S. SOG at center of room, slab approx. 4" thick	No. 8 Scan 5 Wall: Jack, Rm 521: Orange-vert & horiz reinf (dashed line not grouted), greet-joint reinf
