Washington Elementary School District  
October, 11 2016

RE: Roof Assessment  
Tumbleweed Elementary School  
Campus Wide  
Phoenix, Arizona

At your request PRM, LLC. scheduled and conducted a roof assessment on October 4, 2016 at the above referenced facility. The objective of the inspection was to assess the current roof conditions and note deficiencies that may exist and provide recommendations. Photographs and core samples were taken during the inspection to document our findings. Buildings inspected consisted of the following roof areas:

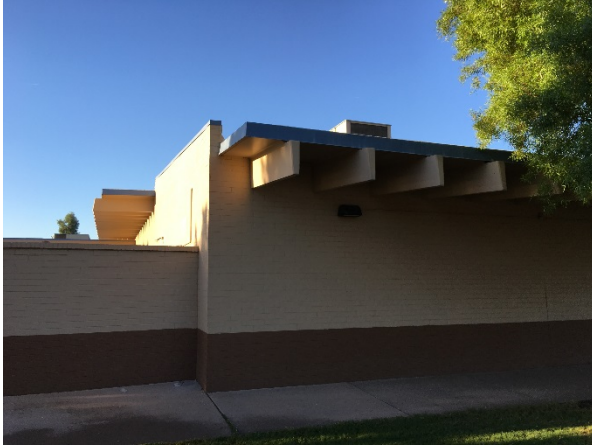
Building-C concrete-T structure

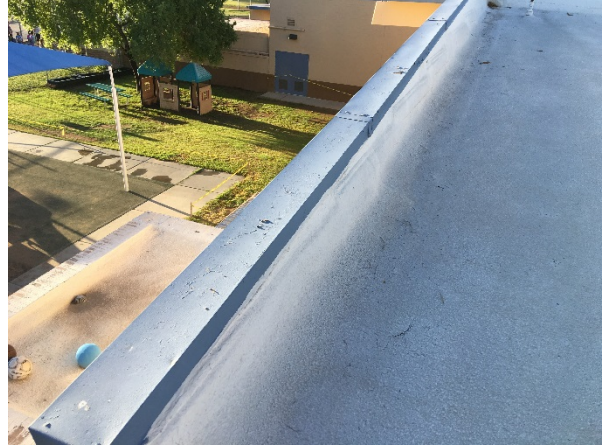
The parapet walls are CMU and have a painted metal coping that wraps over the masonry. The base flashing from the roof is a modified sheet that run under the coping and are now covered with foam and appear to be in poor condition. The roof also has roof top equipment located throughout the roof screened area. The equipment is supported by roof curbs and wood sleepers as required. There is

Building-C typical parapet

It is recommended that the roof systems, flashings and all sheet metal be replaced and that the existing roof be removed to the concrete deck. The recommended roof systems are a BUR with a mineral cap over a ½ inch fiber board over a minimum 2.0 inches of polyisocyanurate. A thermal coating should be installed over the mineral cap. There may be an opportunity to add additional insulation to reduce heat gain if the building interior is not insulated under the deck. This will be verified during design.

It is recommended that the foam roof system including perimeter coping and flashings be replaced. During the design process a proper wind uplift design must be completed to ensure proper fastener or adhesive selection and spacing. In addition, verification of structural slope must be verified to determine if the slope is in the deck or insulation.

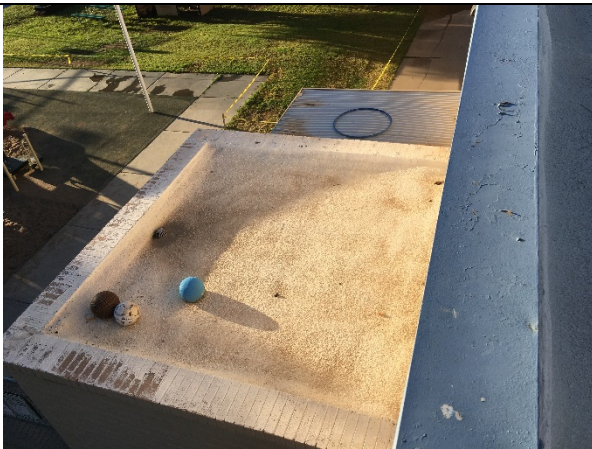
Building C lower roof

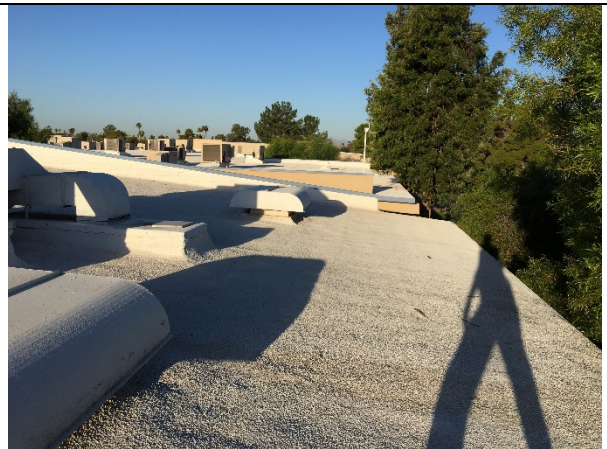
Building C typical blistering

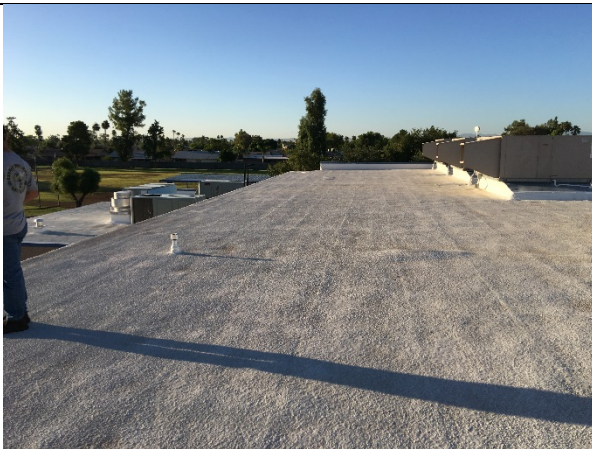
Building C typical overview – BUR lines telegraphing through the foam

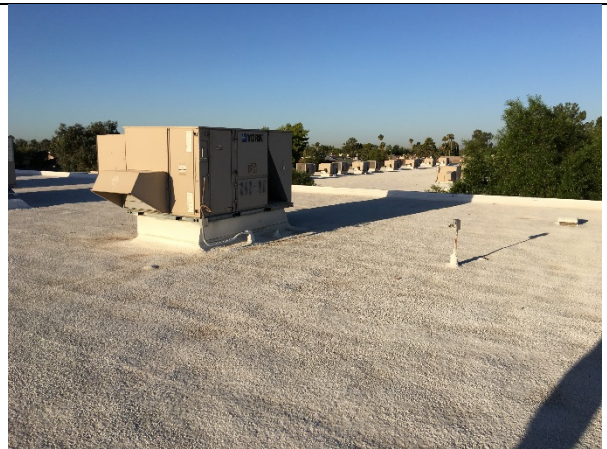
Building C typical blistering

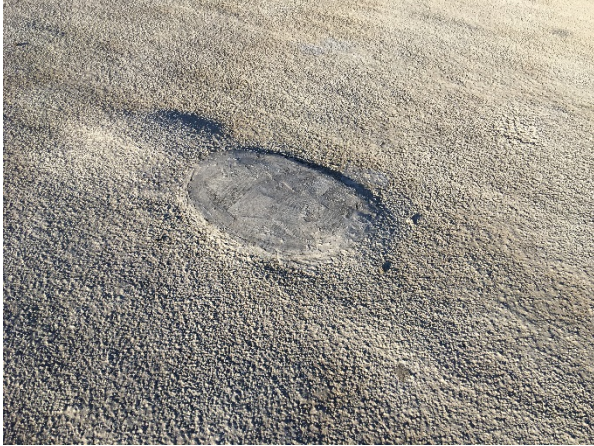
Building C improper blister repair

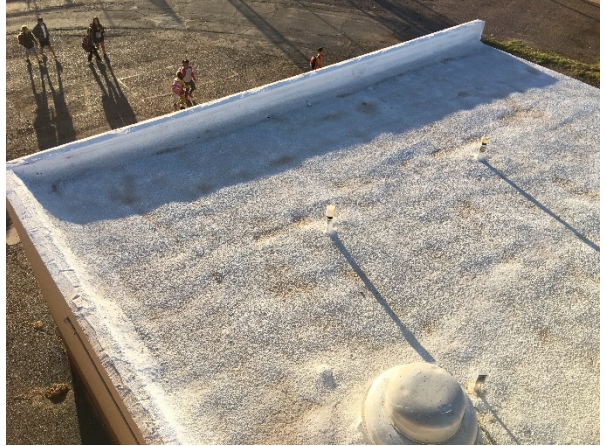
Building C blistering lower roof

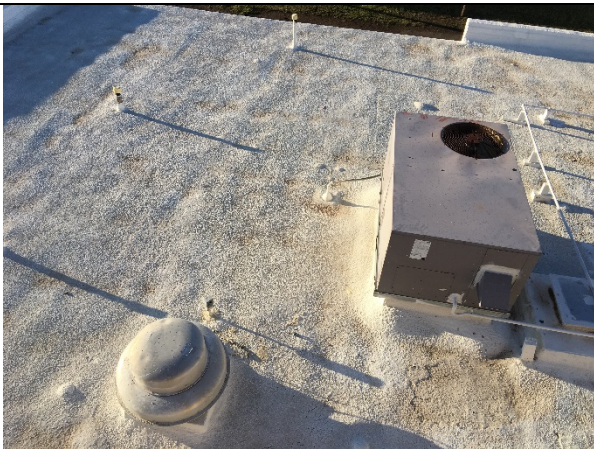
Building C blistering lower roof

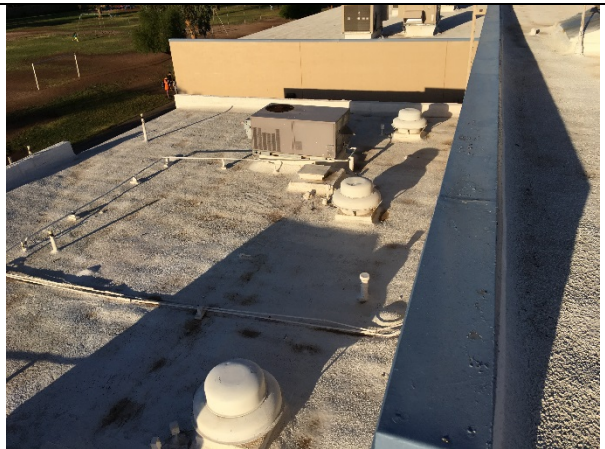
Building C blistering

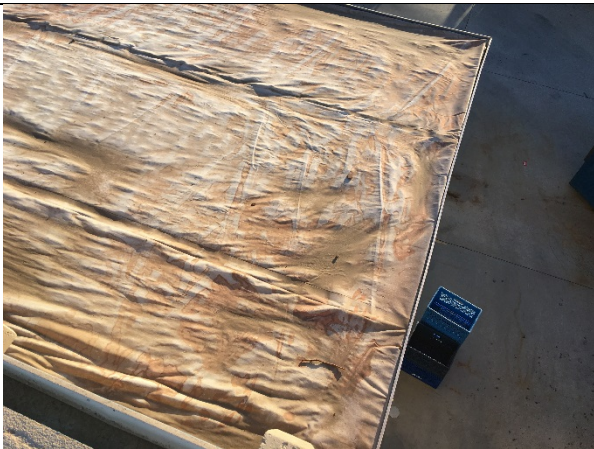
Building C – single ply failure at lower roof

It is recommended that the single ply roof systems also be replaced with an 80 mill single ply roof systems at the existing walk-in. Drainage and slope must be verified during the design.

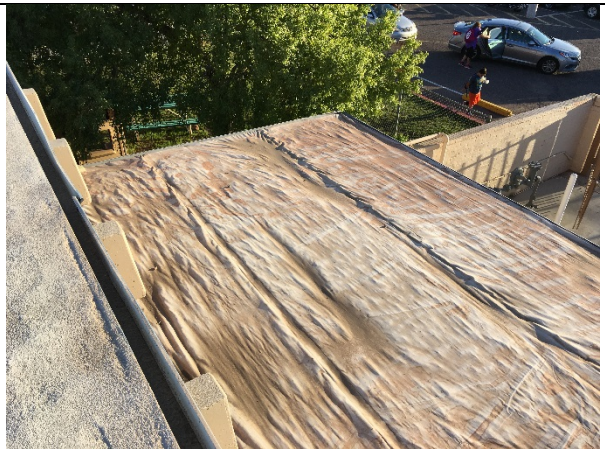
Building C – single ply failure at lower roof

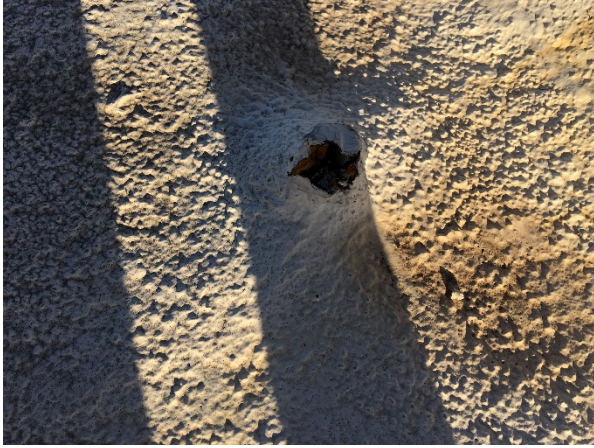
Building C blister puncture

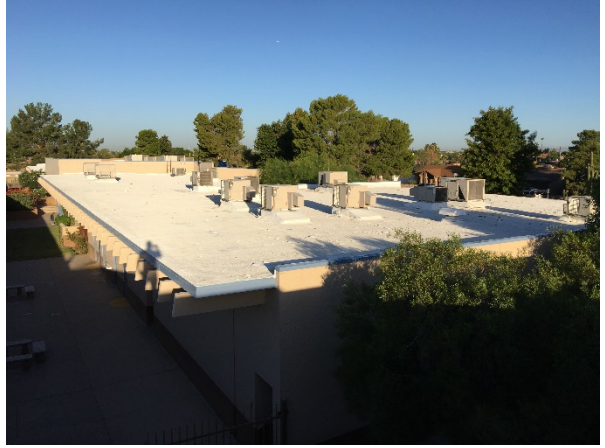
Building A overview

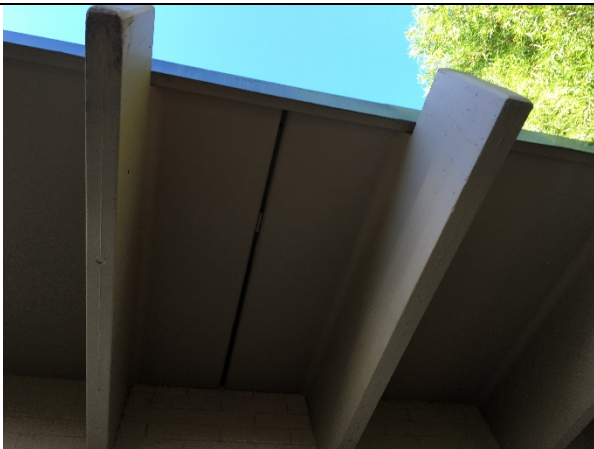
Building A concrete-T

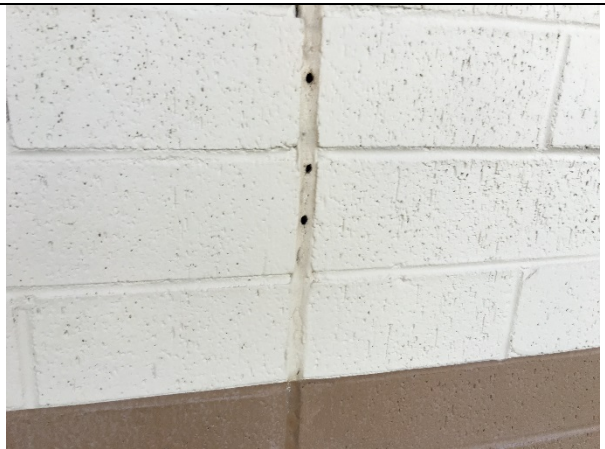
Building A failing caulk joint

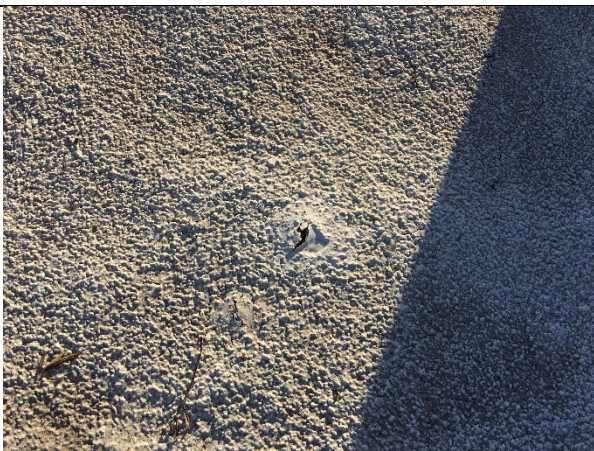
Building A blisters

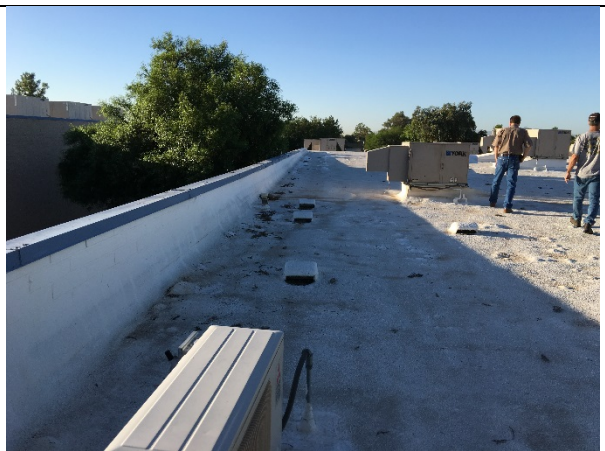
Building A overview with blisters

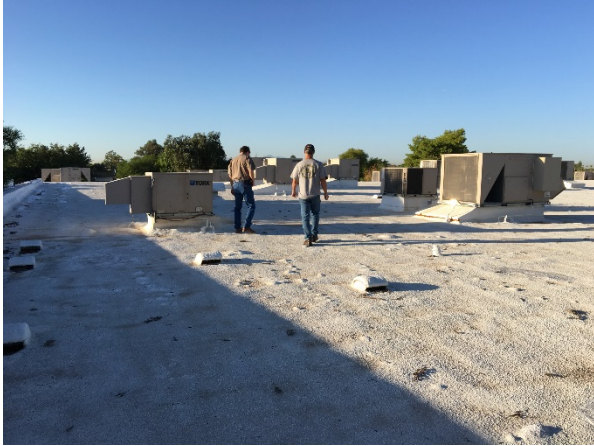
Building A blistering

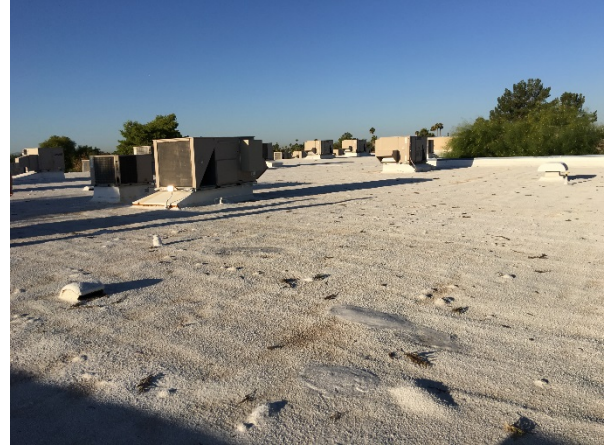
Building A blistering

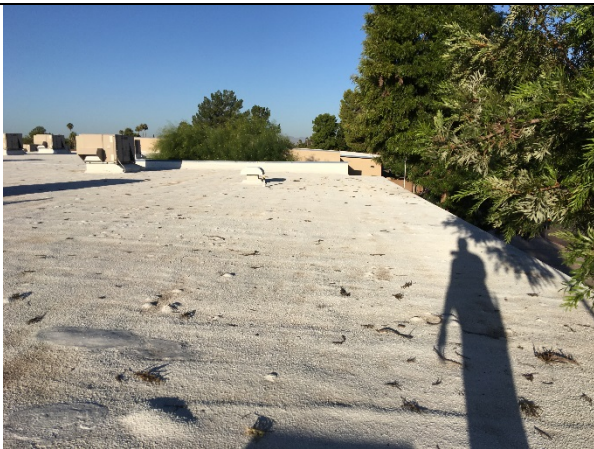
Building A blistering

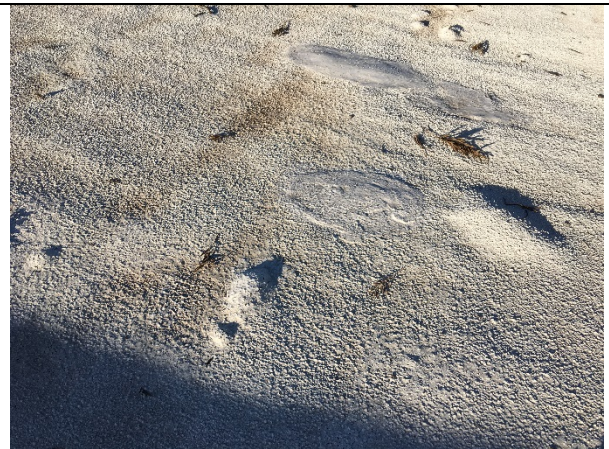
Building A blistering and patching

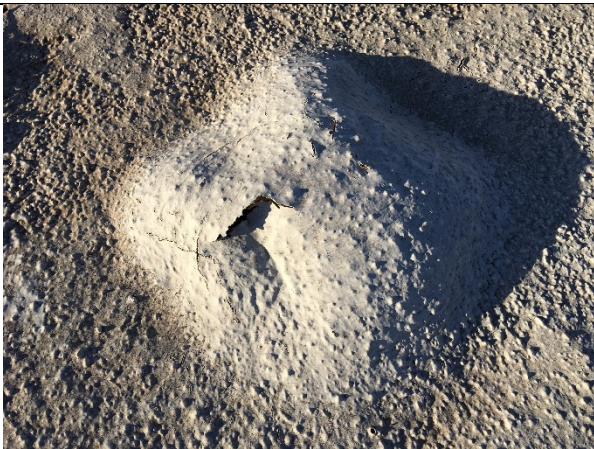
Building A blister puncture

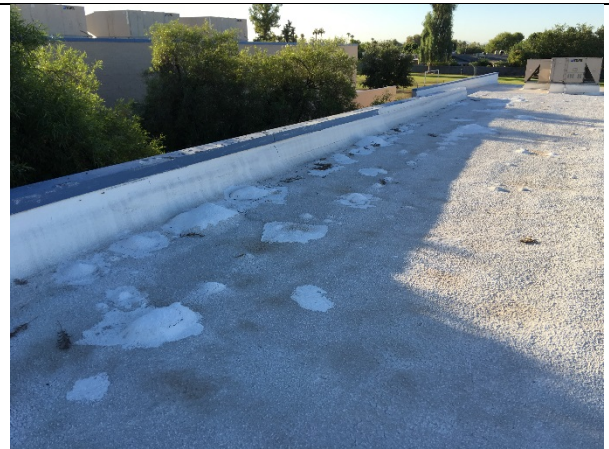
Building A blistering

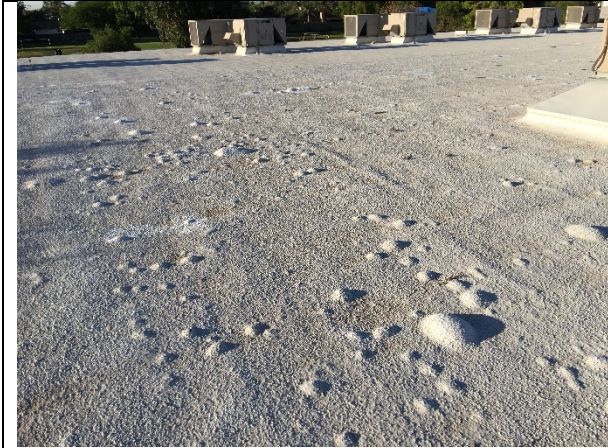
Building A typical blistering

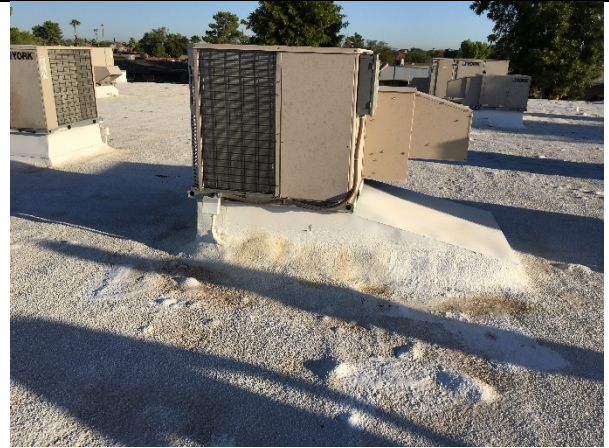
Building A blistering and HVAC curb

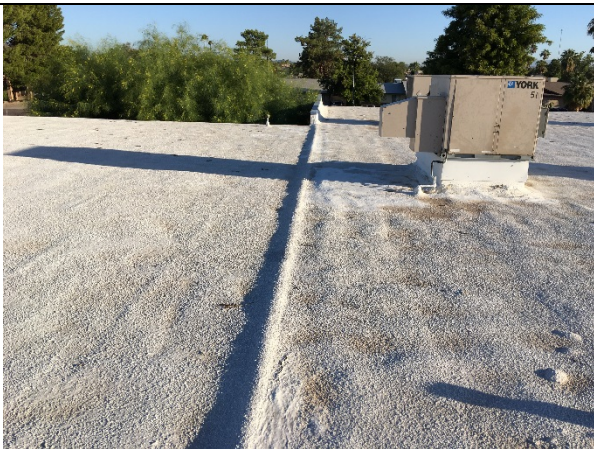
Building A blistering

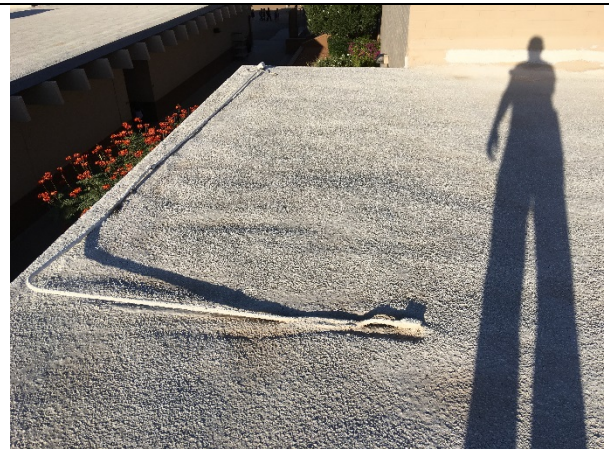
roof top conduit that is supported on the roof with blocking to support the conduit and raise it above the roof. These details appear to be in poor condition.

Building A conduit penetration detail

It is recommended that the roof systems, flashings and all sheet metal be replaced and that the existing roof be removed to the concrete deck. The recommended roof systems are a BUR with a mineral cap over a ½ inch fiber board over a minimum 2.0 inches of polyisocyanurate. A thermal coating should be installed over the mineral cap. There may be an opportunity to add additional insulation to reduce heat gain if the building interior is not insulated under the deck. This will be verified during design.

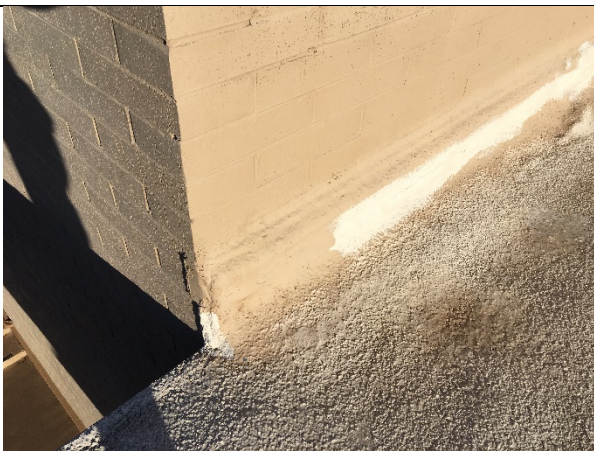
The parapet walls are CMU and have a painted metal coping that wraps over the masonry. The base flashing from the roof is a modified sheet that run under the coping and are now covered with foam and appear to be in poor condition. The roof also has roof top equipment located throughout the roof screened area. The equipment is supported by roof curbs and wood sleepers as required. There is

Building A roof to wall detail

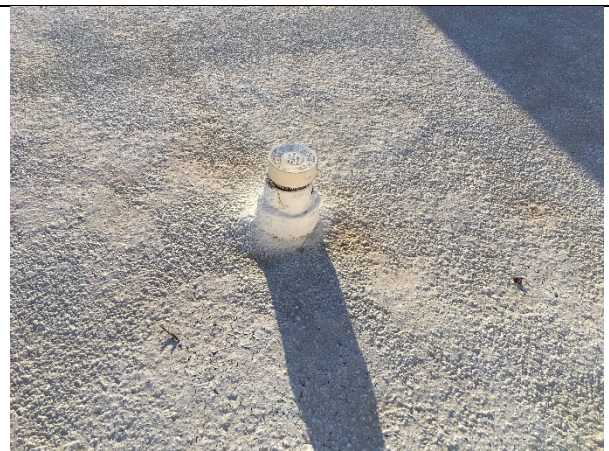
Building A vent detail
