Higley Unified School District
Mr. Ben Bucholz
2935 South Recker Road
Gilbert, AZ 85295

1. Assessment Summary

- 1.1. On May 1, 2018 an Infrastructure Property Condition Assessment of the Cooley Middle School located at 1100 South Recker Road in Gilbert Arizona was conducted by Mr. Ben Bucholz with the Higley Unified School District, Mr. Randolph Marwig with Western Technologies, Mr. Denis Martin with Martin Engineering & Surveying, Inc and David Stover with Orcutt Winslow.

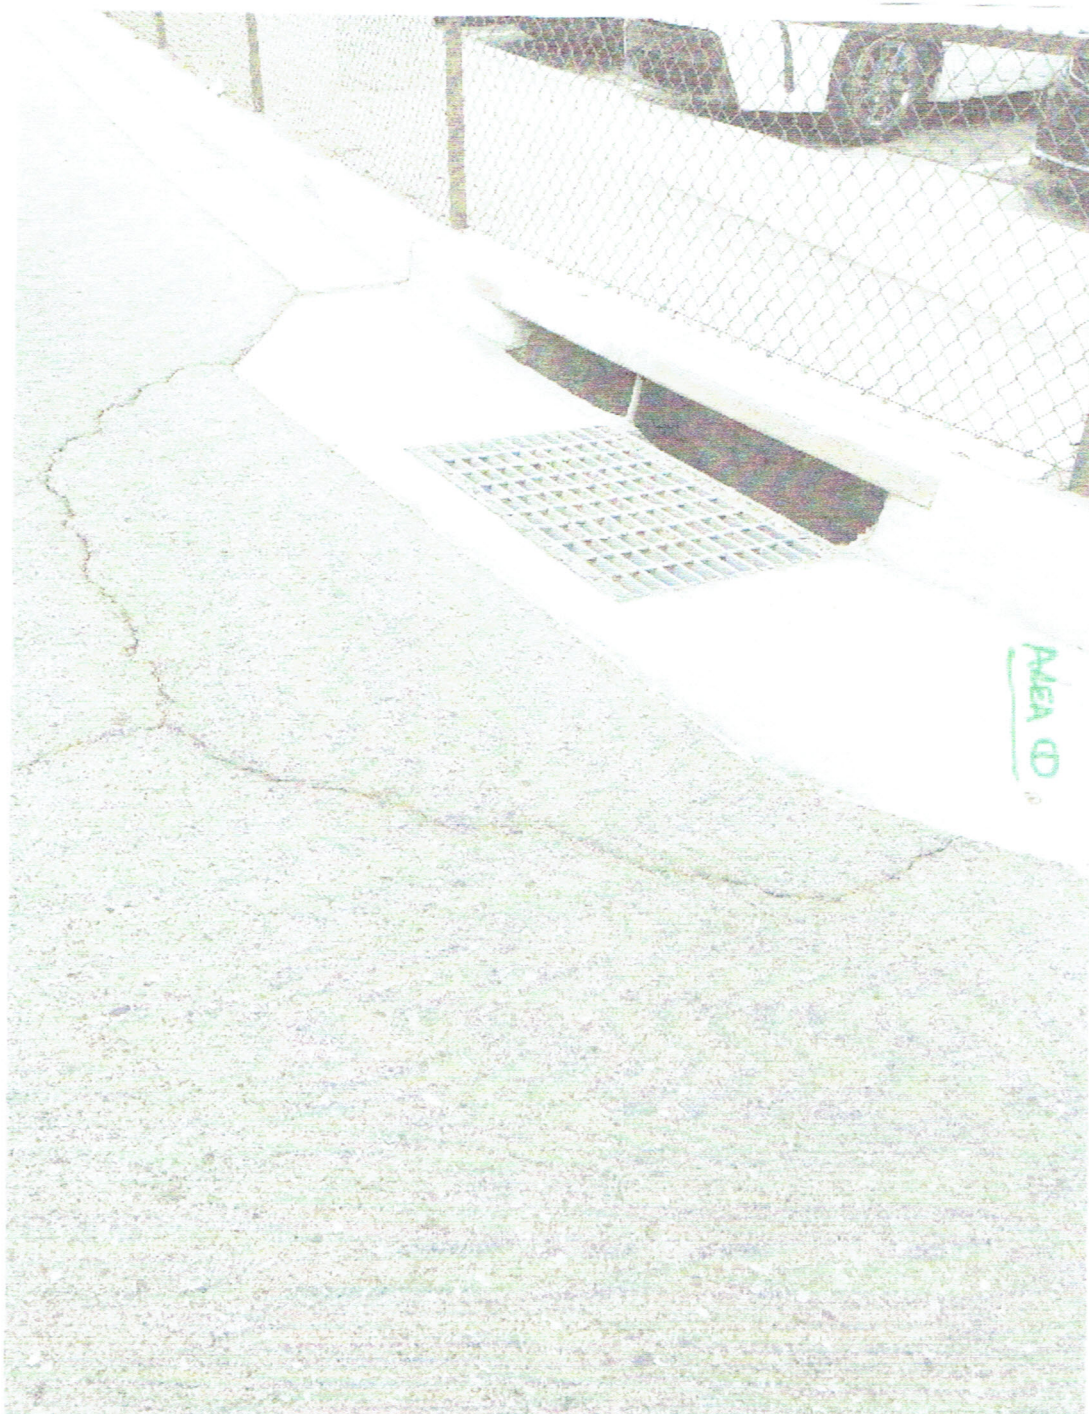
2. Catch basin at northwest portion of parking area

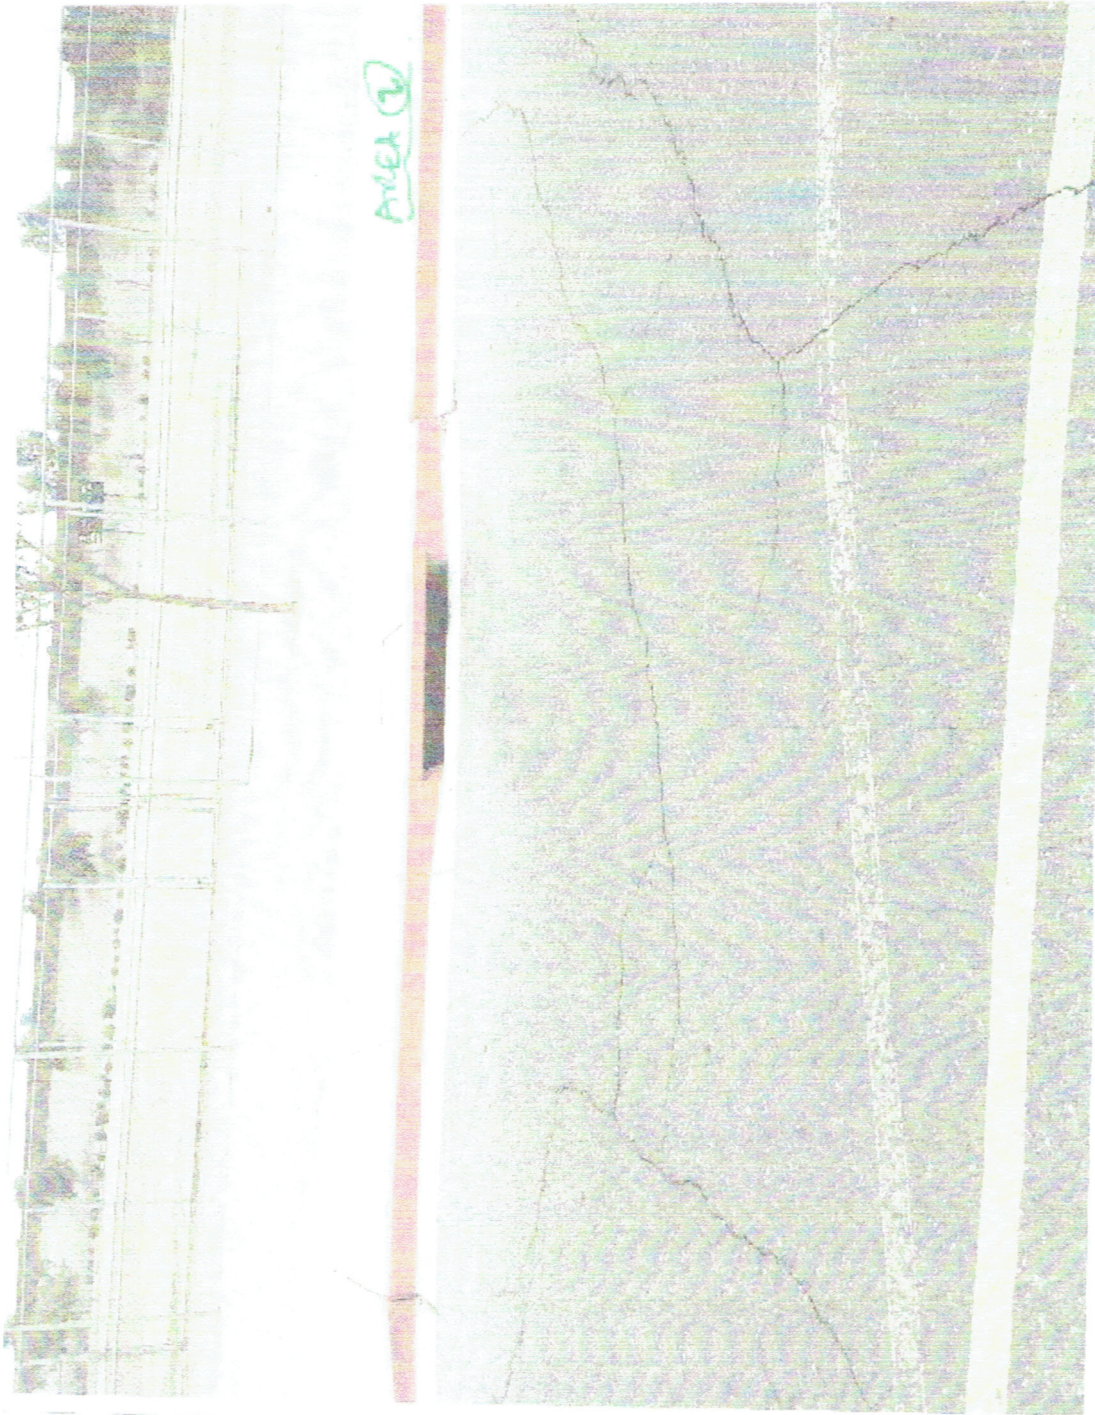
3. Catch basin at southwest portion of parking area
