ROOFING ASSESSMENT

CHEATHAM K-8 SCHOOL
4725 W. South Mountain Ave.
Laveen, AZ 85339

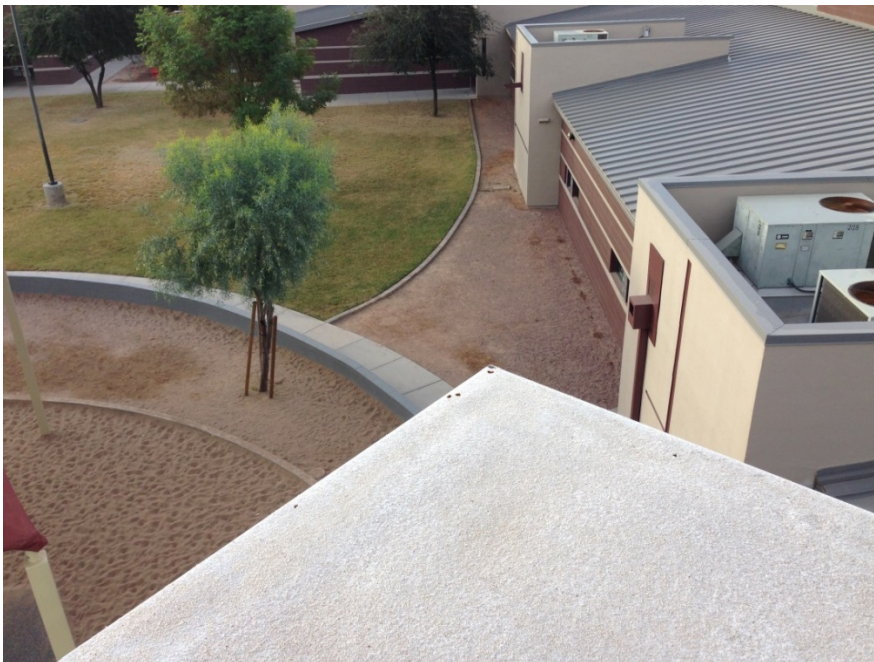
Holes along the gravel stop due to Wood Peckers.

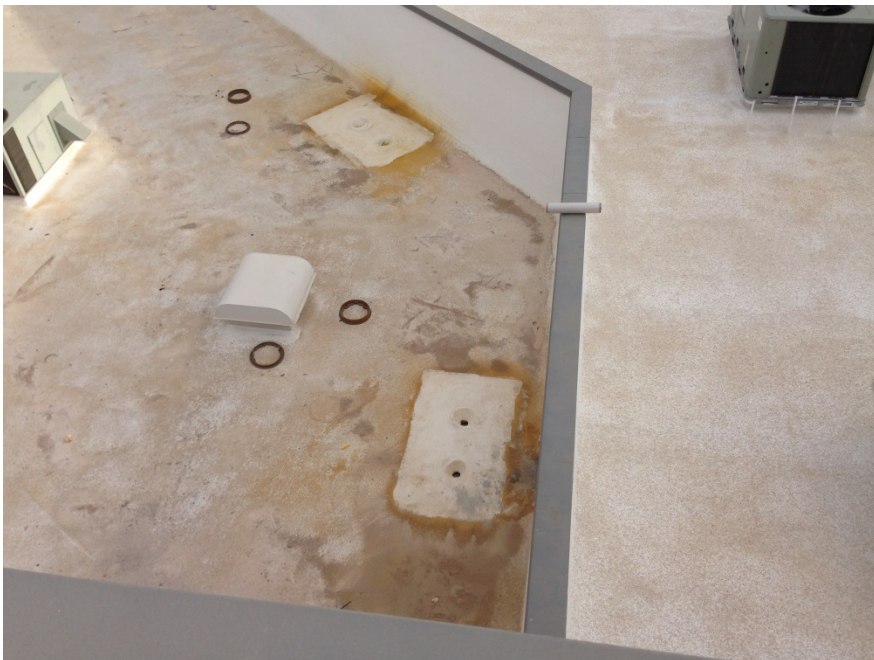
Repaired roof drains adjacent to addition

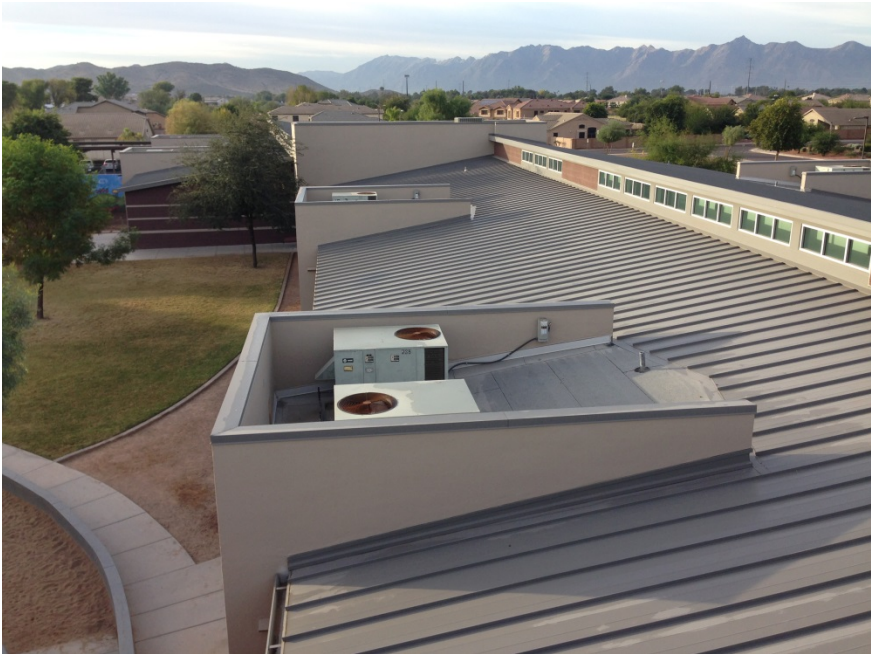
Typical mechanical enclosures at metal roof

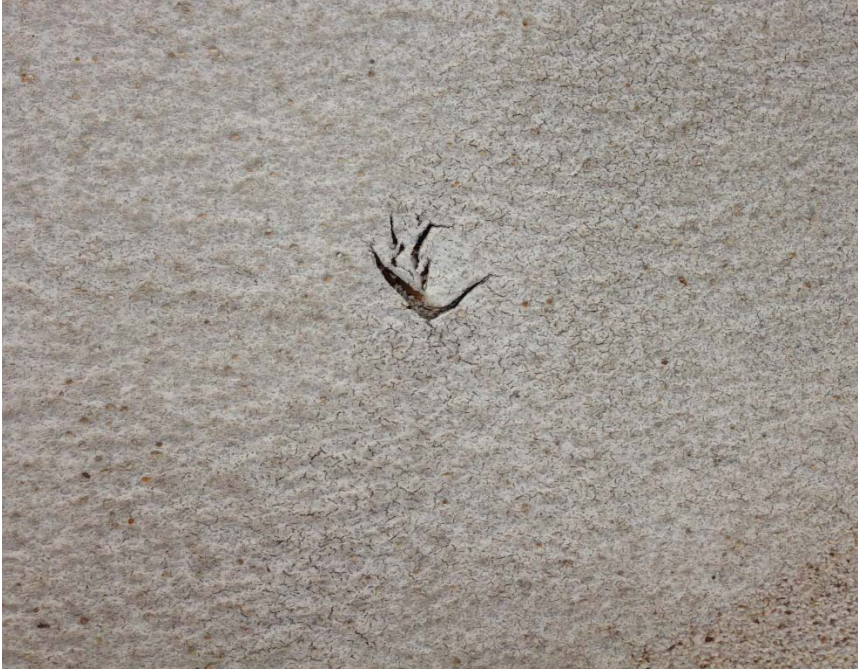
Fractures in cementitious coating

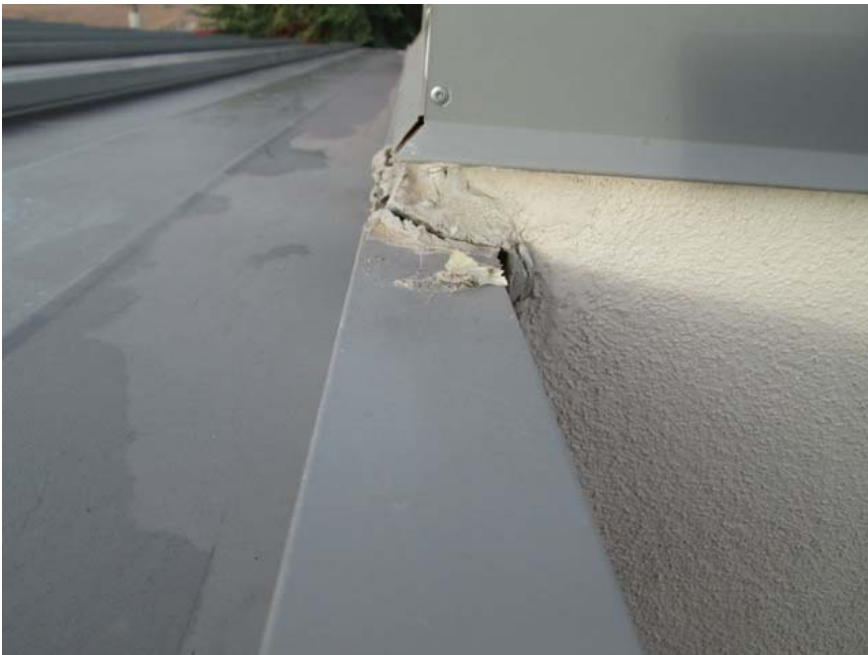
Perimeter sealant voids at metal roofing

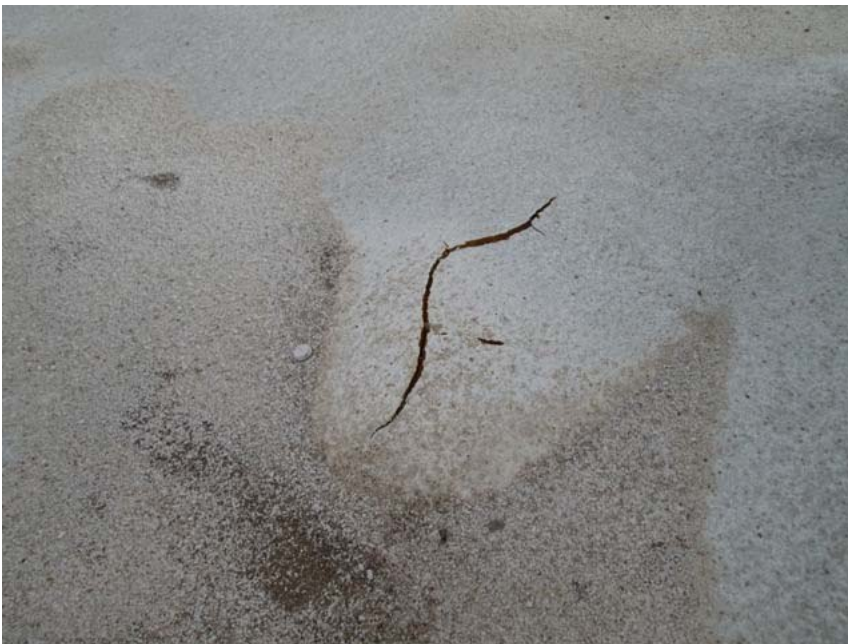
Fractured blister at SW Gym roof (1 of 10)
