# GLENDAL ELEMNTARY SCHOO DISTRICT SFB PROJECT RECAP

# Glendale Elementary School District SFB Projects: Construction Cost Estimates

**RE: GESD SFB Deficiency Corrections**  
Landmark, Challenger, Mensendick and Smith

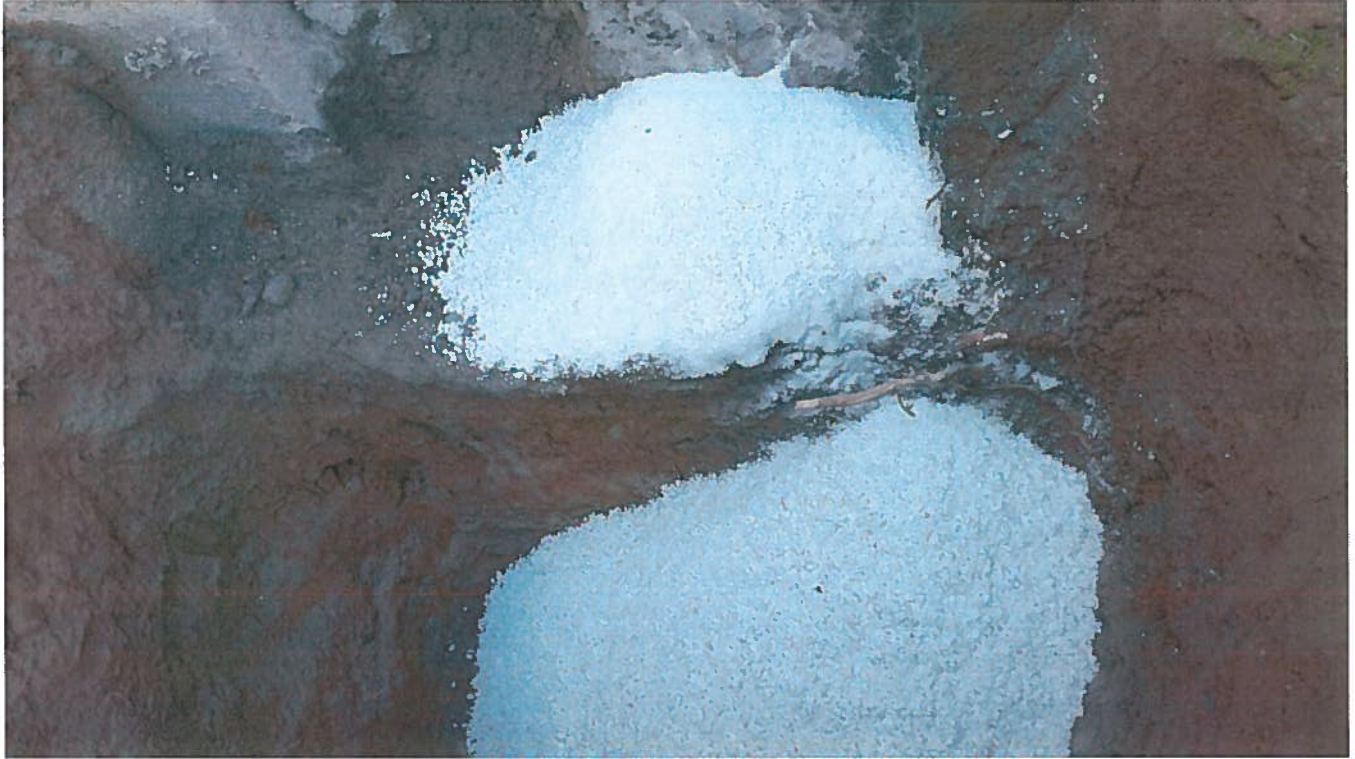
**PICTURE NO. 1**

**LANDMARK – BLDG. 7 - MARKER #1**

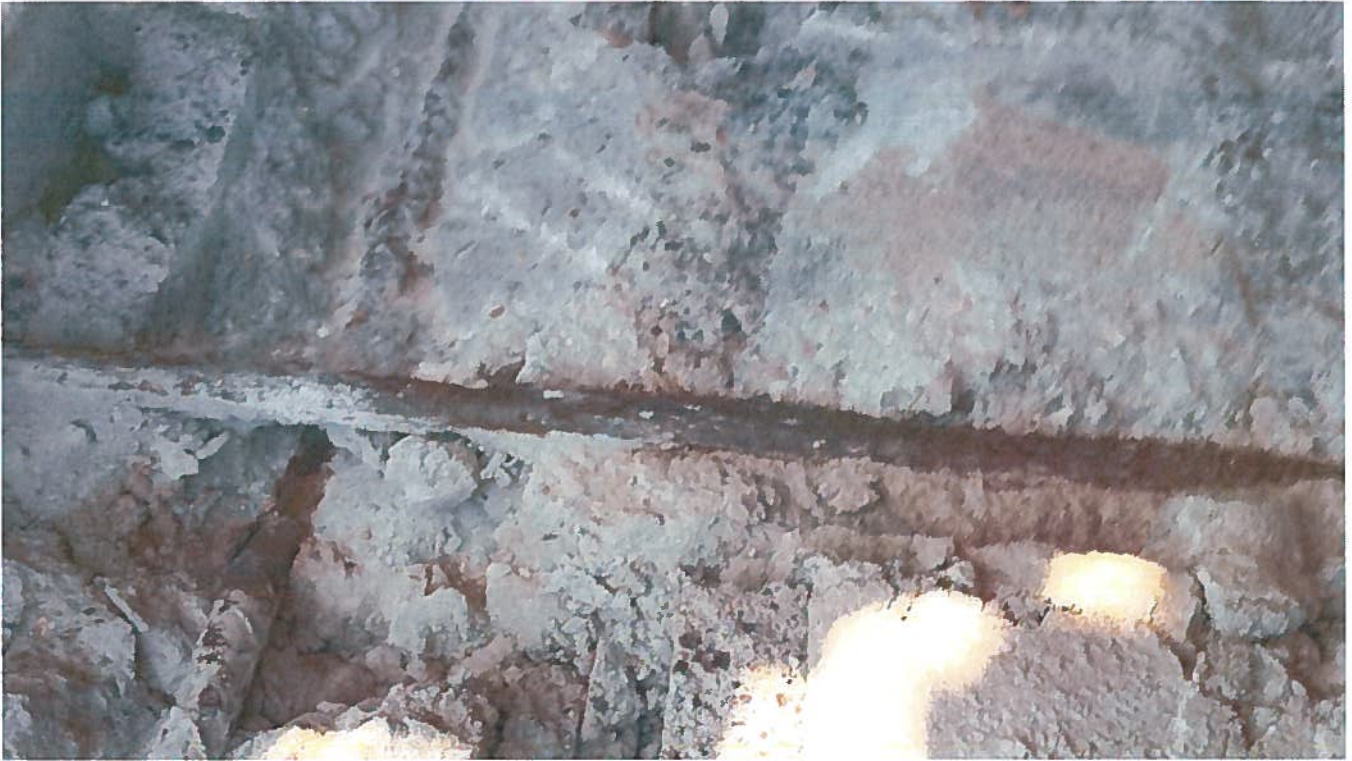
**PICTURE NO. 3**

**LANDMARK – BLDG. 7 - MARKER #1**

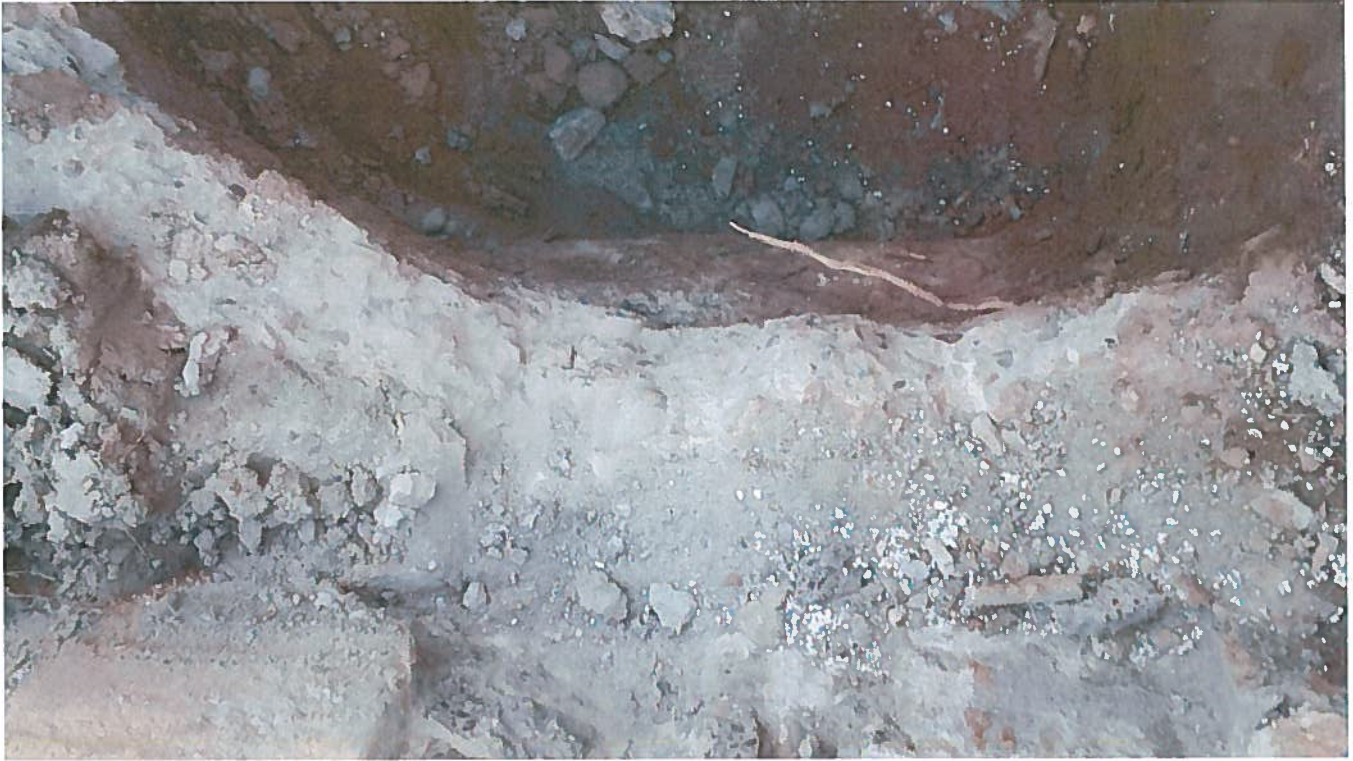
**PICTURE NO. 1**

**LANDMARK – BLDG. 3 - MARKER #2**

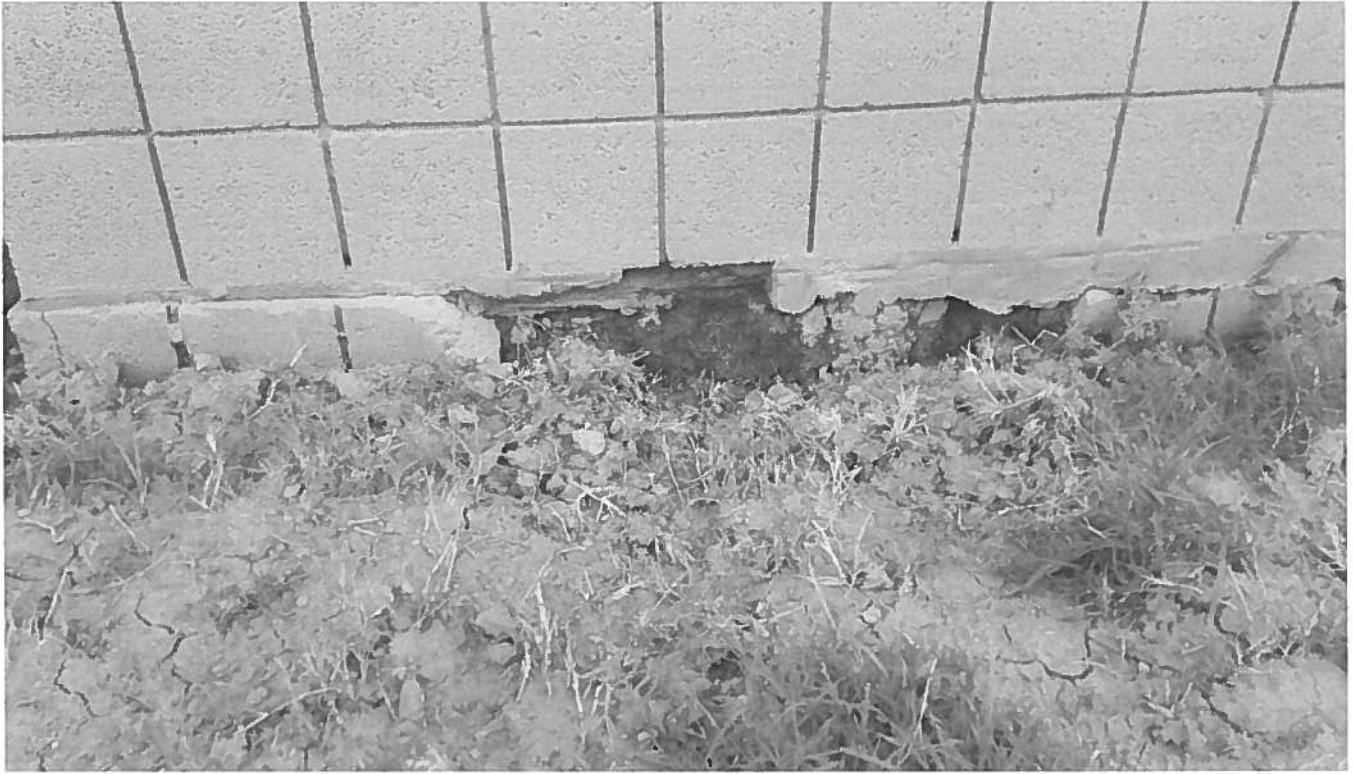
**PICTURE NO. 1**

**LANDMARK – BLDG. 2 - MARKER #3**

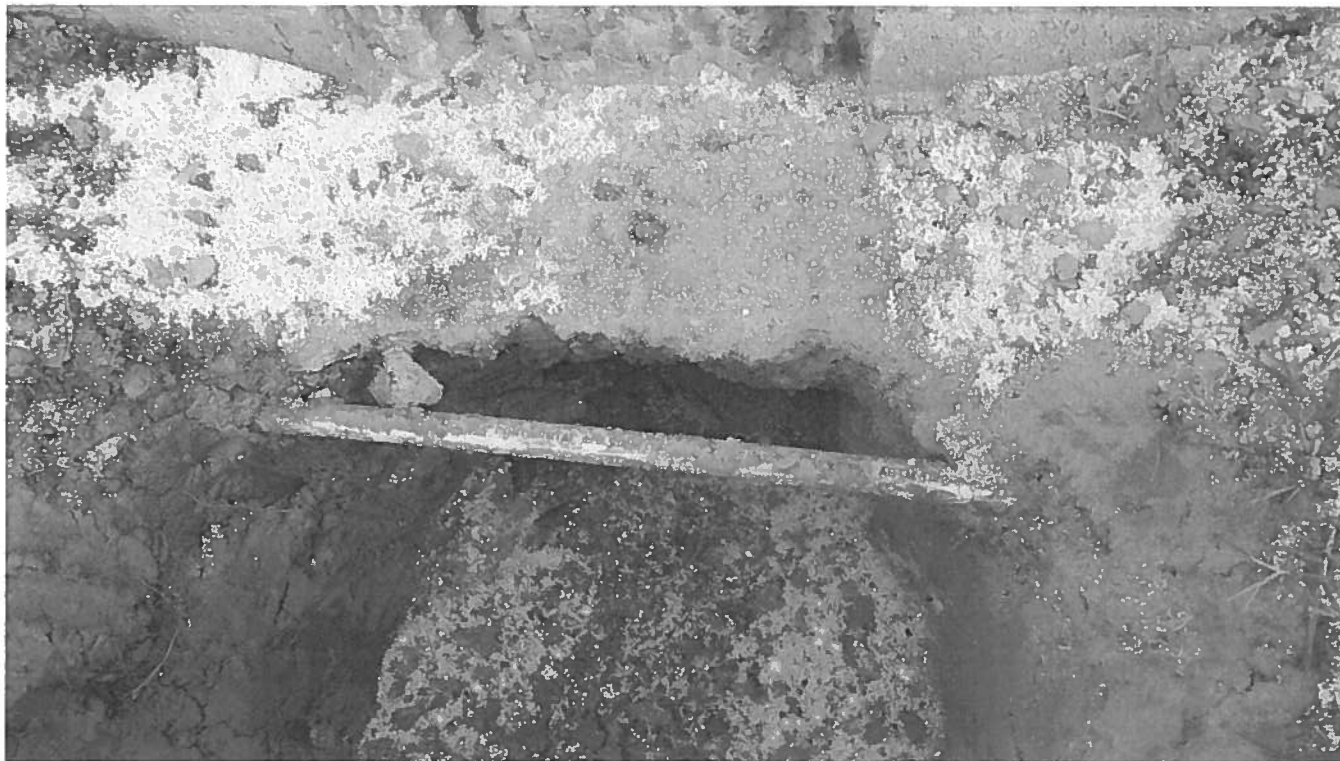
**PICTURE NO. 3**

**LANDMARK – BLDG. 2 - MARKER #3**

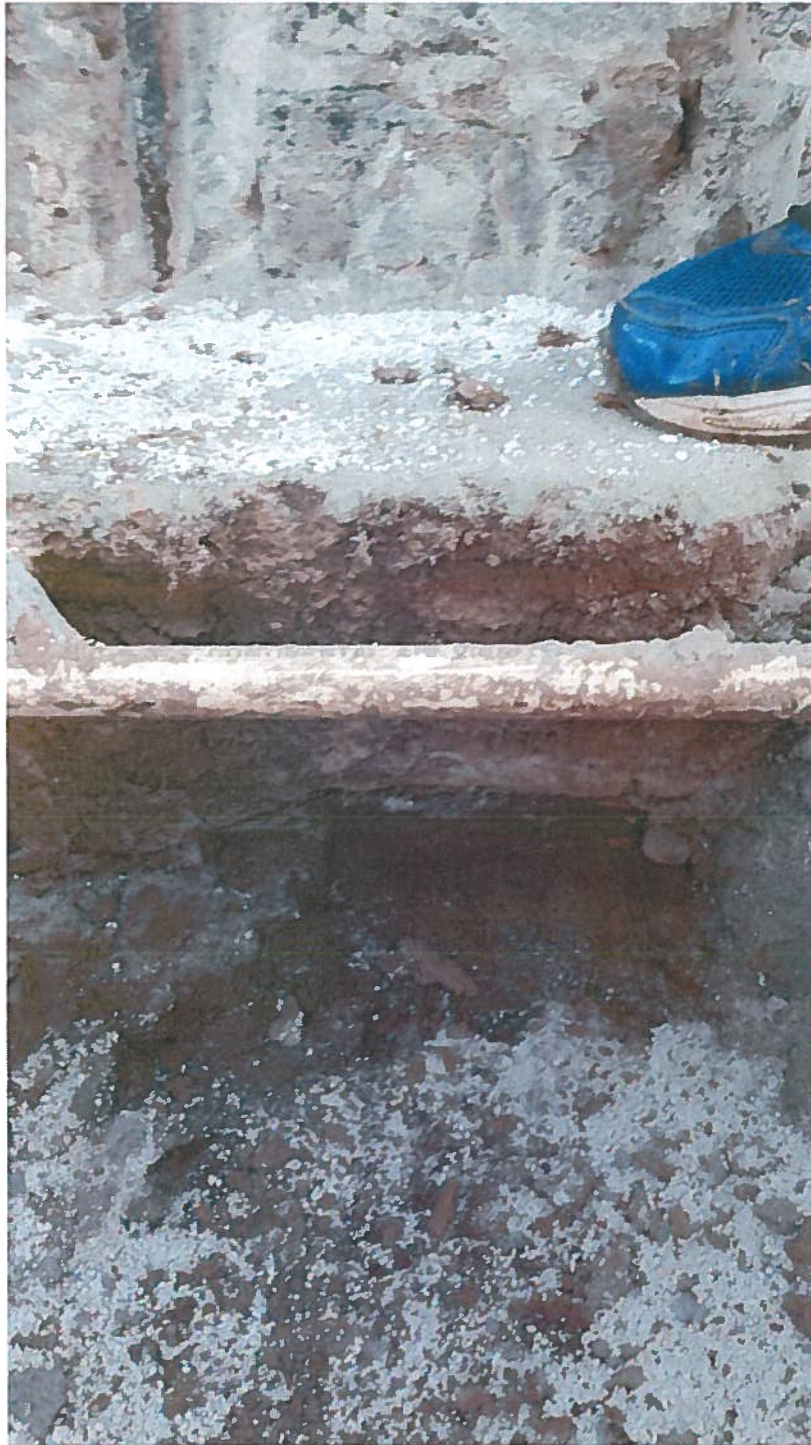
**PICTURE NO. 4**

**LANDMARK – BLDG. 2 - MARKER #3**

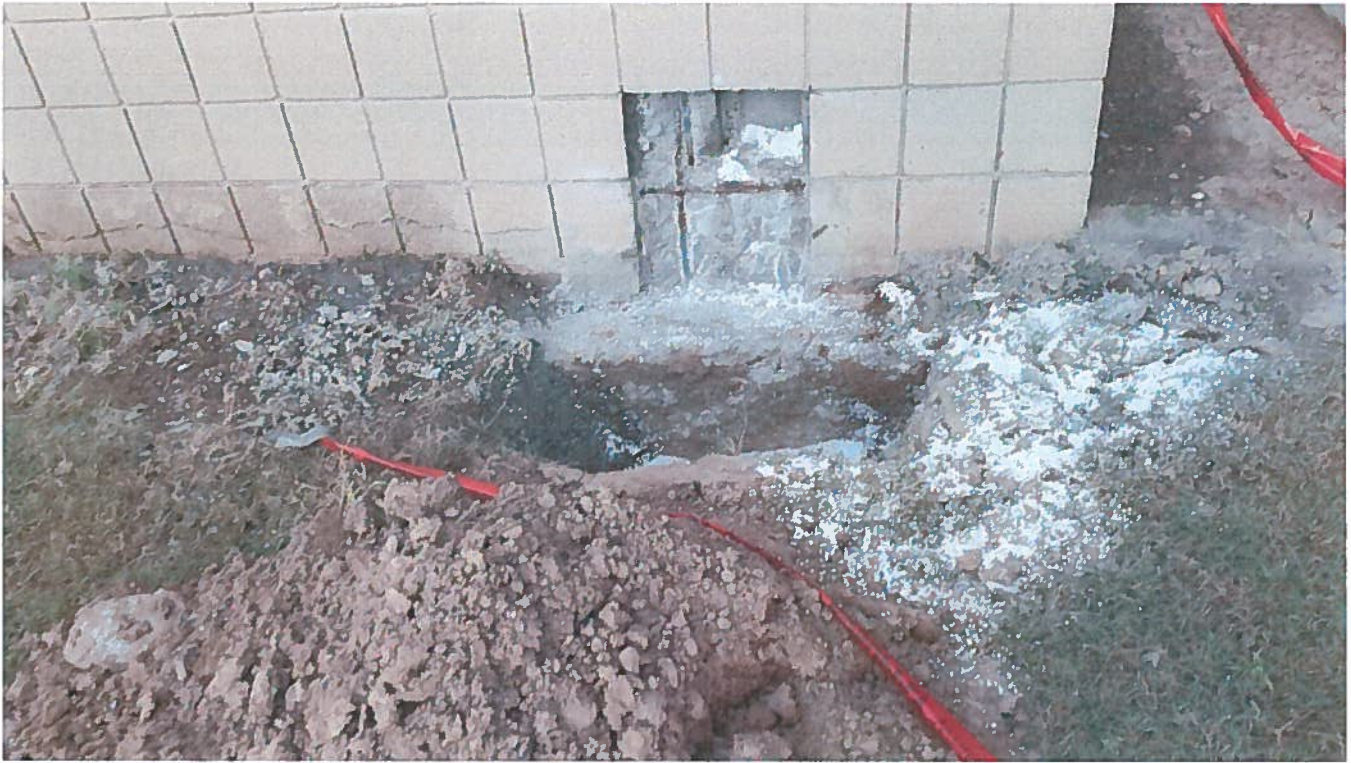
**PICTURE NO. 1**

**LANDMARK – BLDG. 1 - MARKER #4**

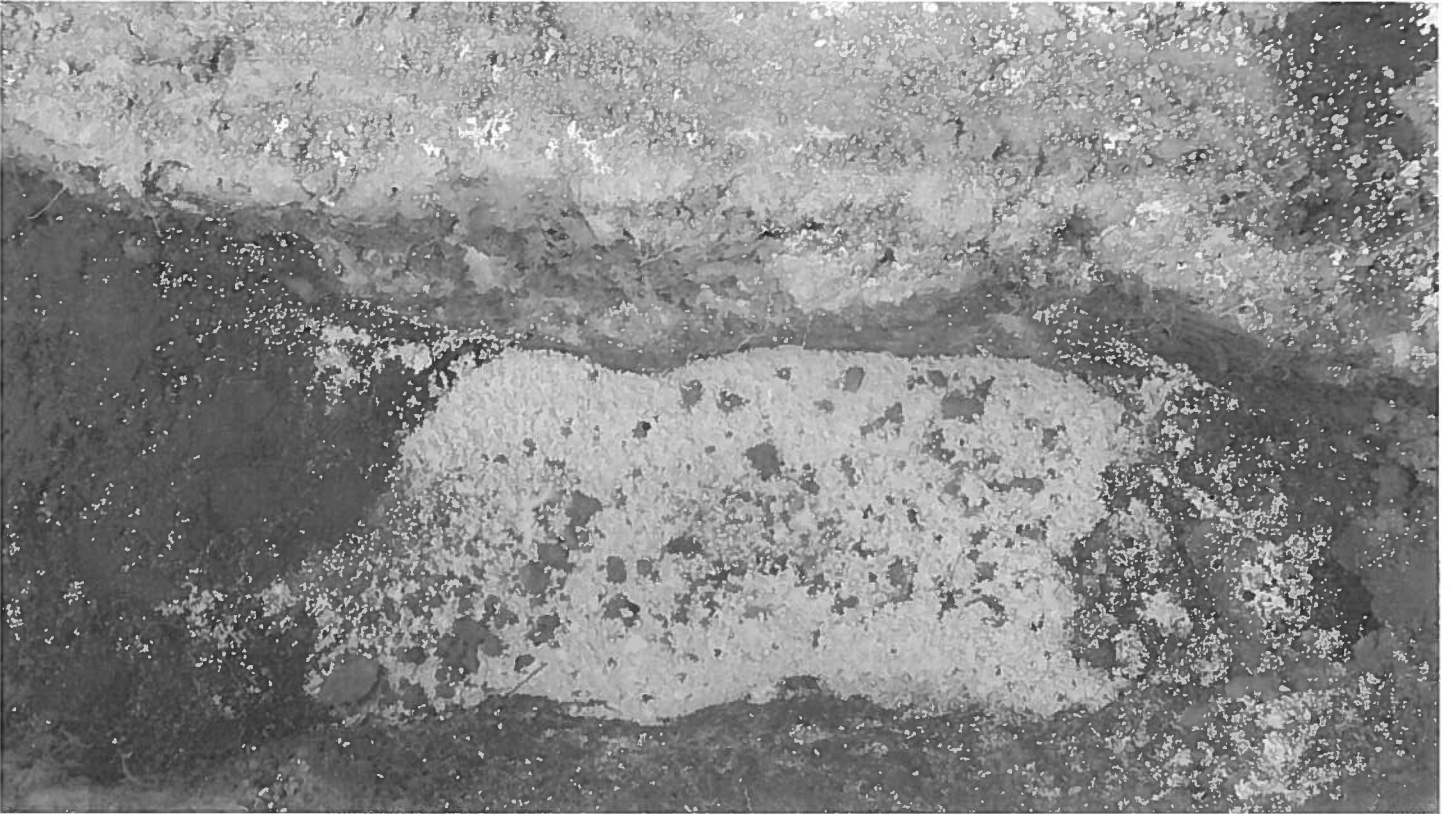
**PICTURE NO. 3**

**LANDMARK – BLDG. 1 - MARKER #4**

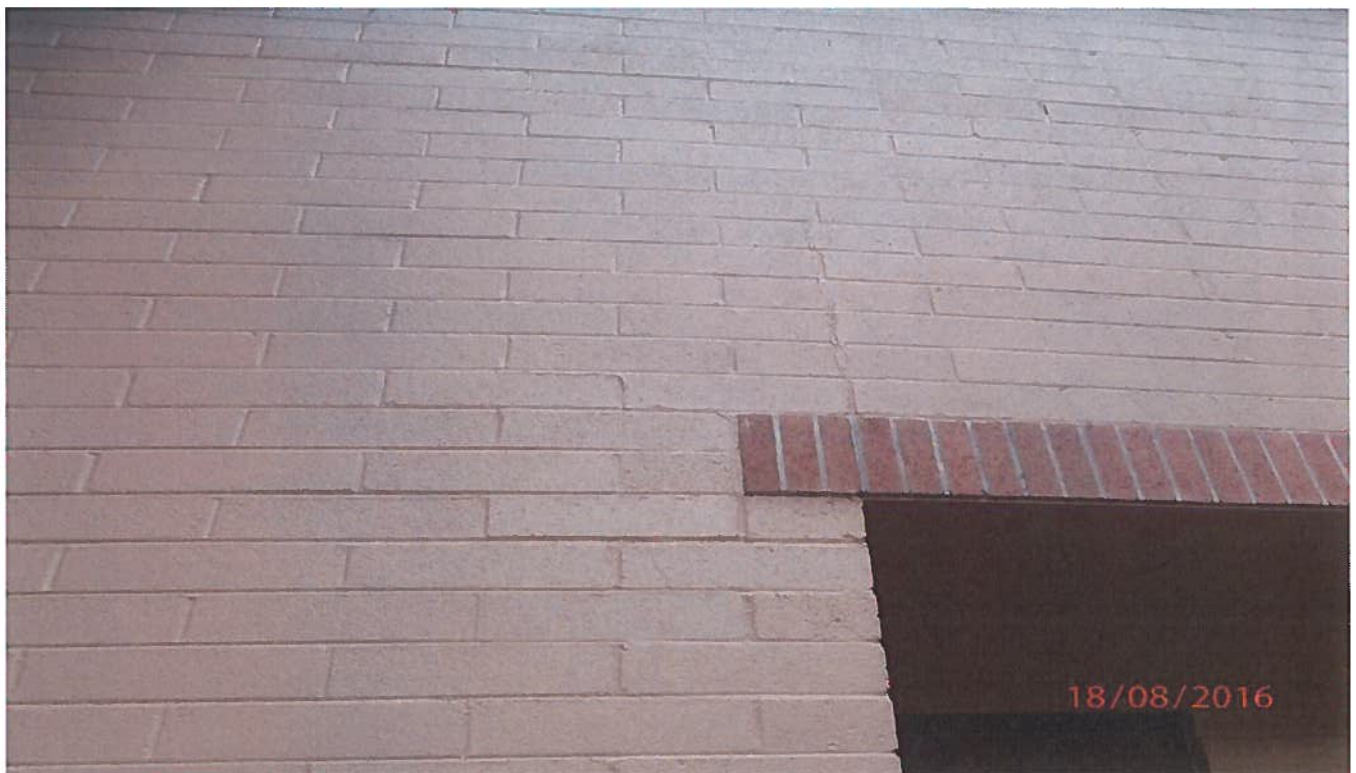
**MARKER NO. 8**

1. There were several areas where there are shrinkage cracks, most likely due to insufficient or improper locations of masonry control joints, or improperly installed masonry control joints (see photographs 8 and 11 on building 1, photos 4 and 9 on building 2, photo 6 and 15 on building 3 and photo 1 on building 6 and photo 3 on building 7). While these are not structural in nature, they will affect the waterproofing integrity of the building and therefore I recommend that new masonry control joints be installed and for the CMU in these areas to be tuck pointed and repaired or replaced as applicable. There were approximately 10-15 locations throughout the school where this occurred.

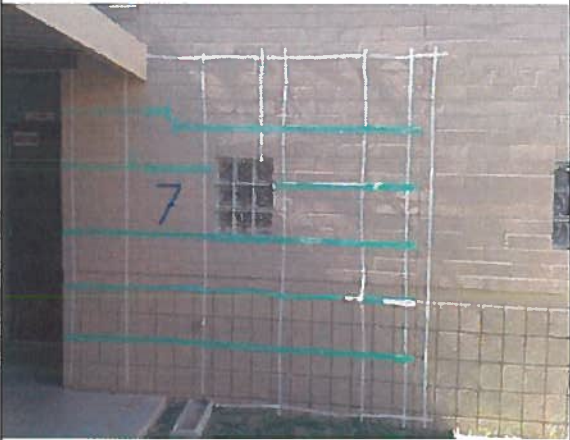
<p>No. 7 Scan 7 Wall: Bldg. H, PD Room, N. Wall. White-vert. &amp; horiz. reinf (grouted), Green-joint reinf.</p>

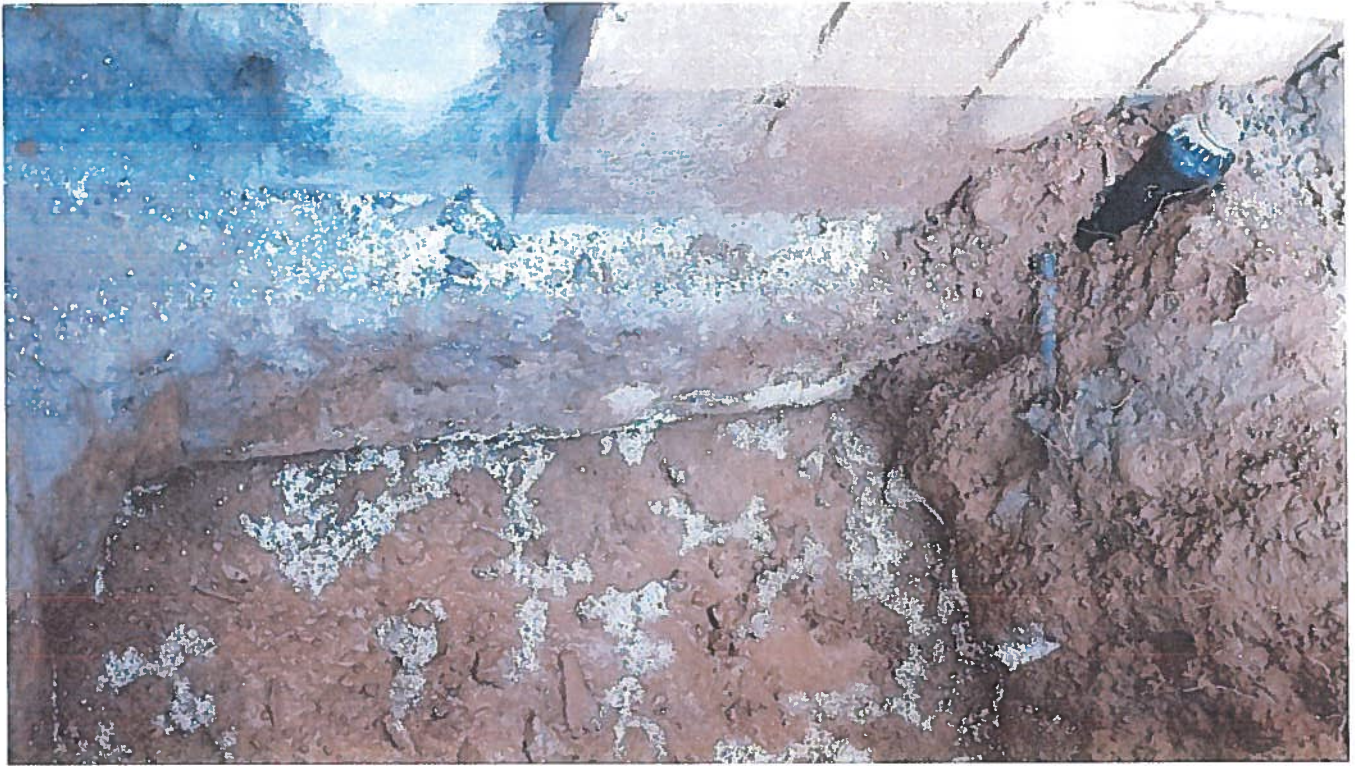
PICTURE NO. 1

## CHALLENGER – BLDG. 1 - MARKER #1

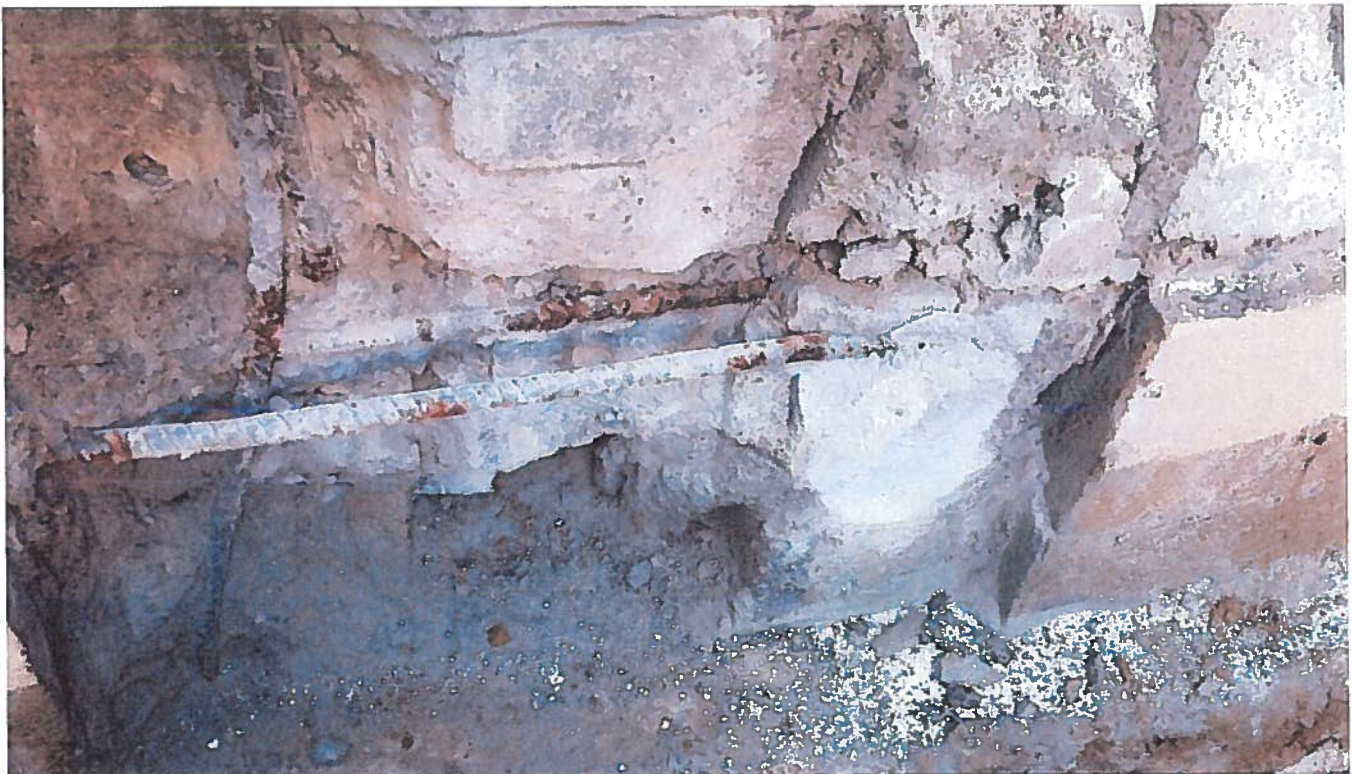
PICTURE NO. 2

**CHALLENGER – BLDG. 1 - MARKER #1**

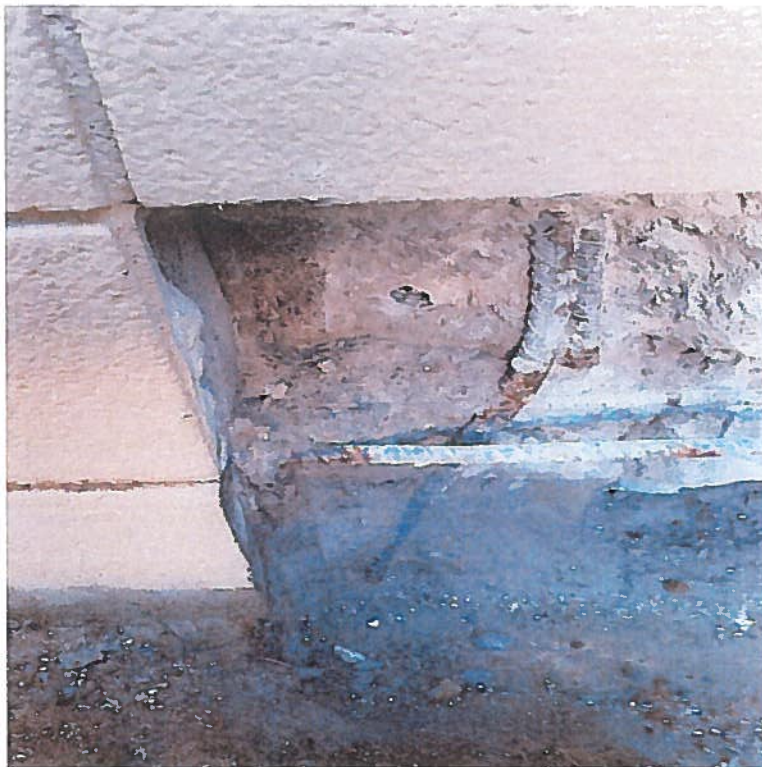
**PICTURE NO. 4**

**CHALLENGER – BLDG. 1 - MARKER #1**

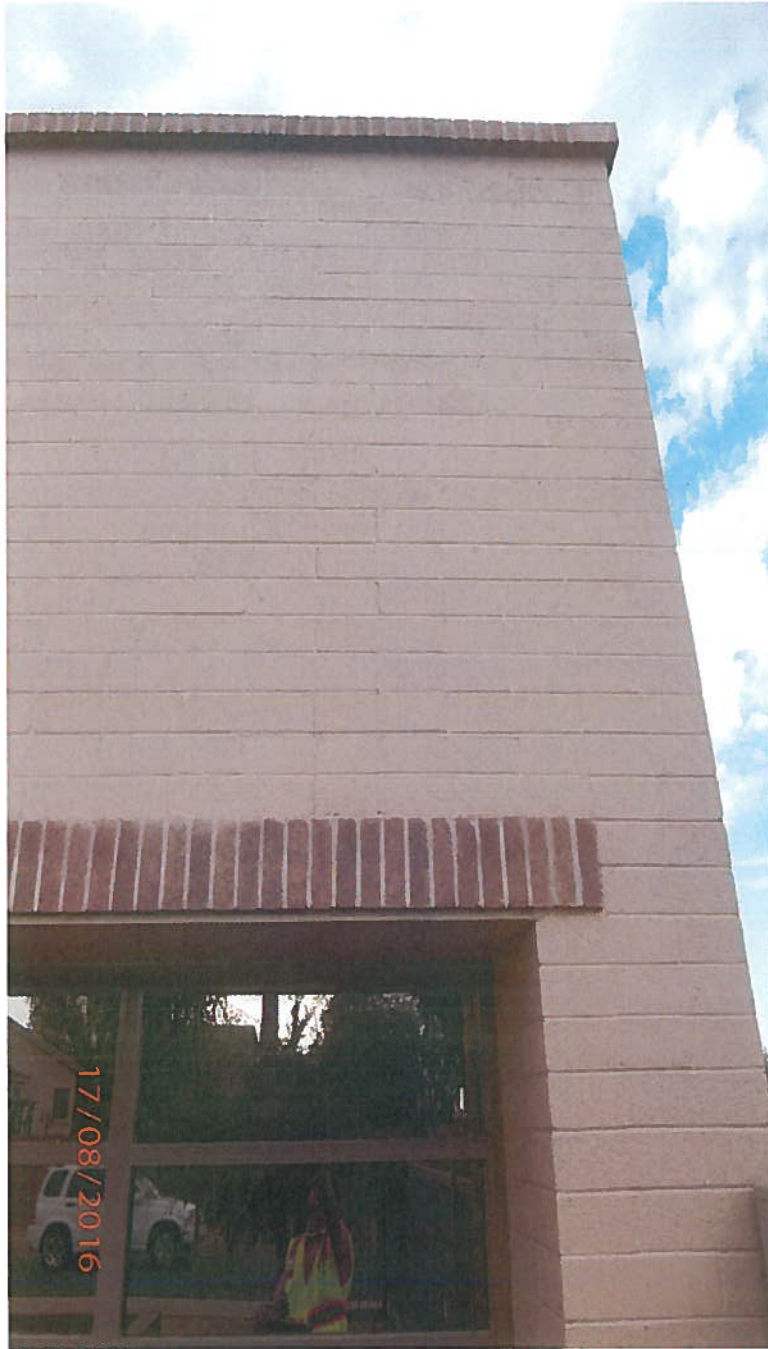
MARKER NO. 1

1. There were several areas where there are shrinkage cracks most likely due to insufficient or improper locations of masonry control joints or improperly installed masonry control joints (see photographs 1, 2, 4 and 7 on building 1, photos 1, 5 and 12 on building 2, photo 6 on building 6 and photo 4 on building 7). While these are not structural in nature they will affect the water tightness of the building and therefore I recommend that new masonry control joints be installed and for the CMU in these areas to be tuck pointed and repaired or replaced as applicable. There were approximately 10-15 locations throughout the school where this occurred.

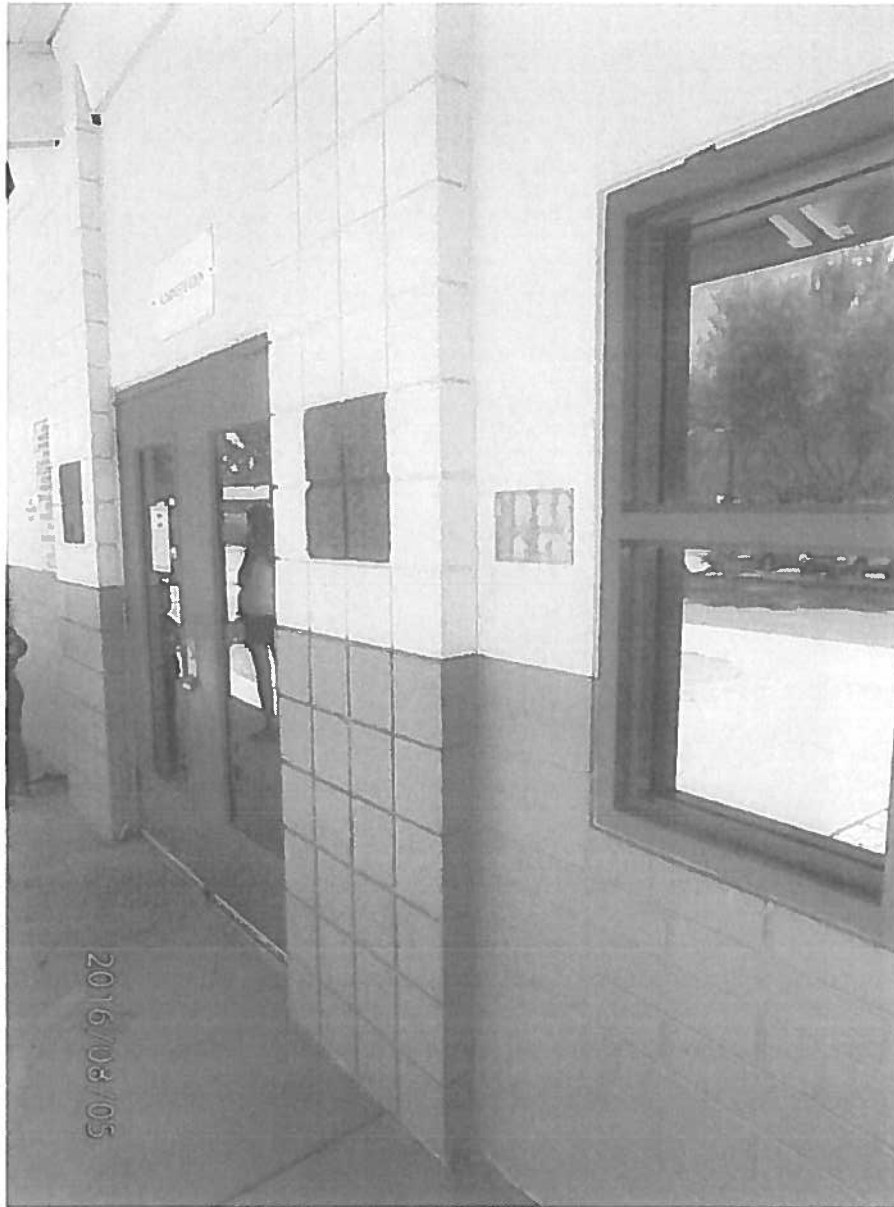
**MARKER NO. 10**

2. There were several areas where there was an added wythe of cmu probably for aesthetic reasons however it does not appear to be attached to the cmu and has a crack along the side of the added wythe (see photo 10 on building 1, photo 1 on building 4, photos 1 and 8 on building 5, photos 1, 5, 6, 15 and 16 on building 7, photos, 5, 6, and 7 on building 9, photos 1, 4 and 5 on building 15, photos 1, 2 and 4 on building 16, photos 1, 6, 7 and 8 on building 17, photo 3 on building 18 and photo 3 on building 22). I would recommend drilling and epoxying some anchors into the supporting wythe to stabilize to stabilize the extra wythe. This probably occurs in approximately 20 locations.

1) Installation of masonry control joints and repair of damaged cmu:	\$80,000
2) Securing of the decorative wythe of cmu:	\$60,000
3) Repair of the cmu surrounding the stair stepped cracks:	\$100,000
4) Install helical piers:	\$400,000
5) Grout injection of slab:	\$100,000
6) Repair of the cracked cmu and rusted reinforcing:	\$250,000

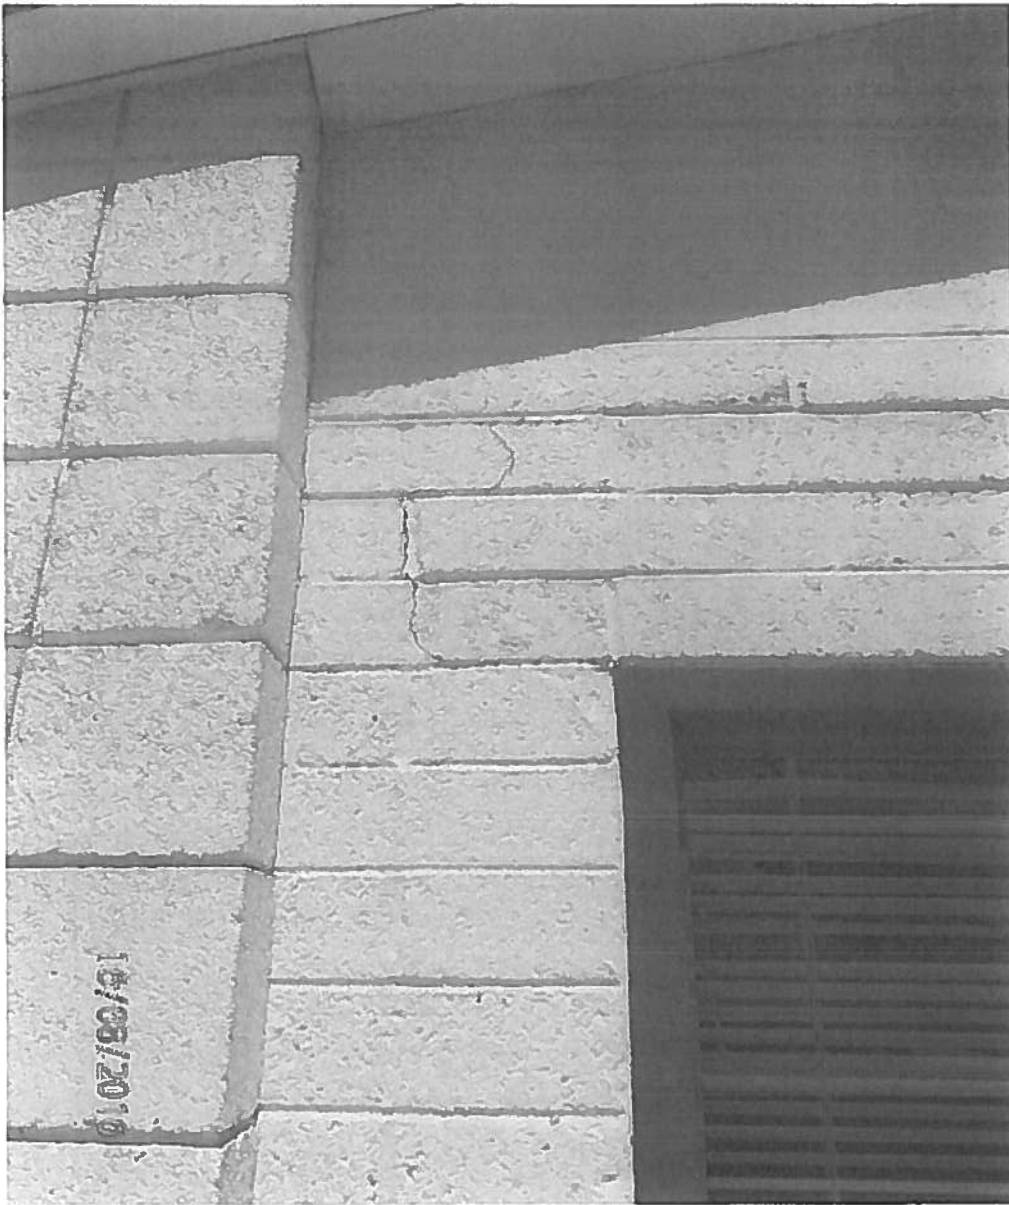
**MARKER NO. 1**

**DON MENSENDICK SCHOOL – BUILDING 22**

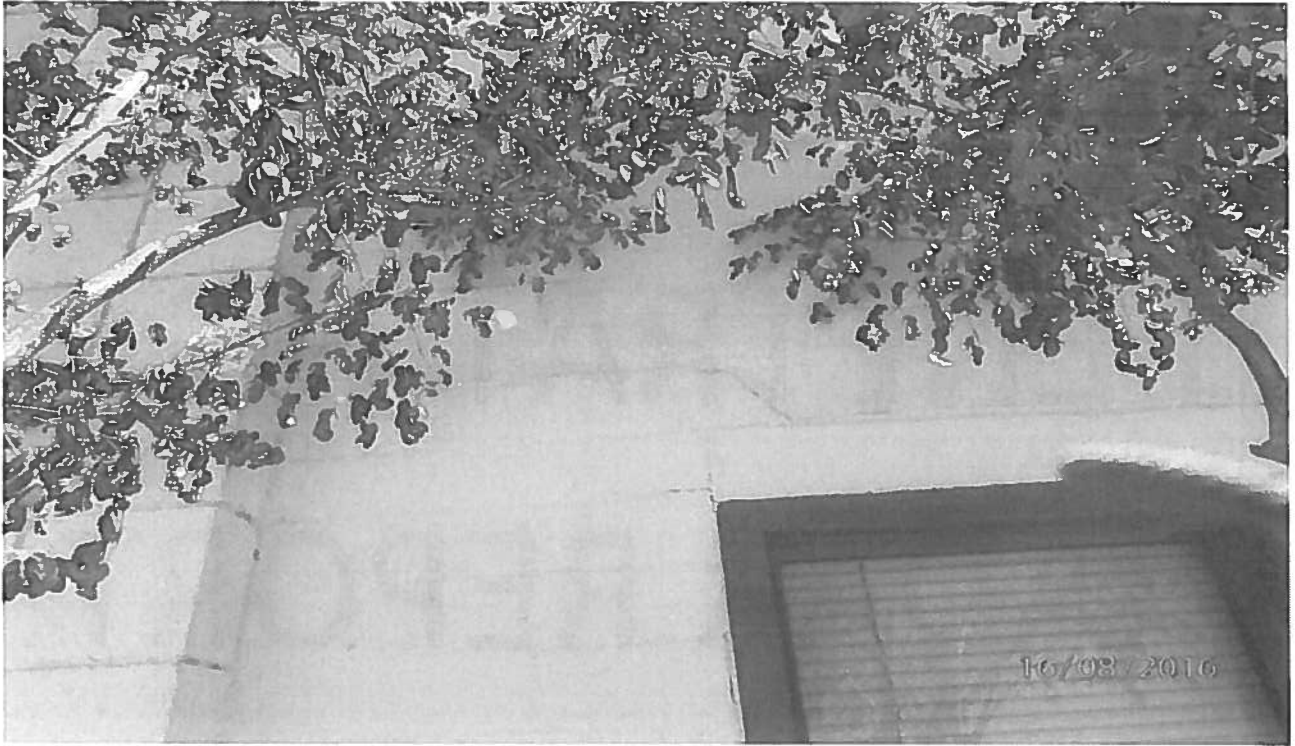
**MARKER NO. 1**

**DON MENSENDICK SCHOOL – BUILDING 24**

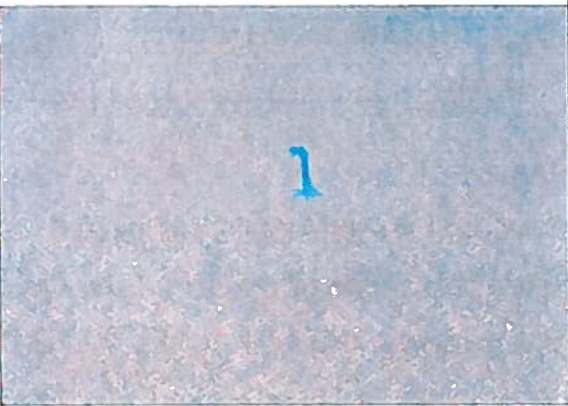
No. 1	Scan 1-Wall: Mensendick, Rm 602, S. wall. Green Tape indicating ungrouted target, possible electrical conduit.	No. 2	Scan 1-SOG: Mensendick, Rm 602. Approx 10'x10' area. slab approx.. 4" Thick.
